**PERFORMANCE ASSESSMENT OF IRRIGATION SCHEMES IN NORTHERN  
GHANA USING COMPARATIVE PERFORMANCE INDICATORS**

**A THESIS SUBMITTED TO THE DEPARTMENT OF AGRICULTURAL  
MECHANISATION AND IRRIGATION TECHNOLOGY, FACULTY OF  
AGRICULTURE IN PARTIAL FULFILMENT OF THE REQUIREMENTS FOR  
THE AWARD OF MASTER OF PHILOSOPHY DEGREE IN SOIL AND WATER  
CONSERVATION AND MANAGEMENT**

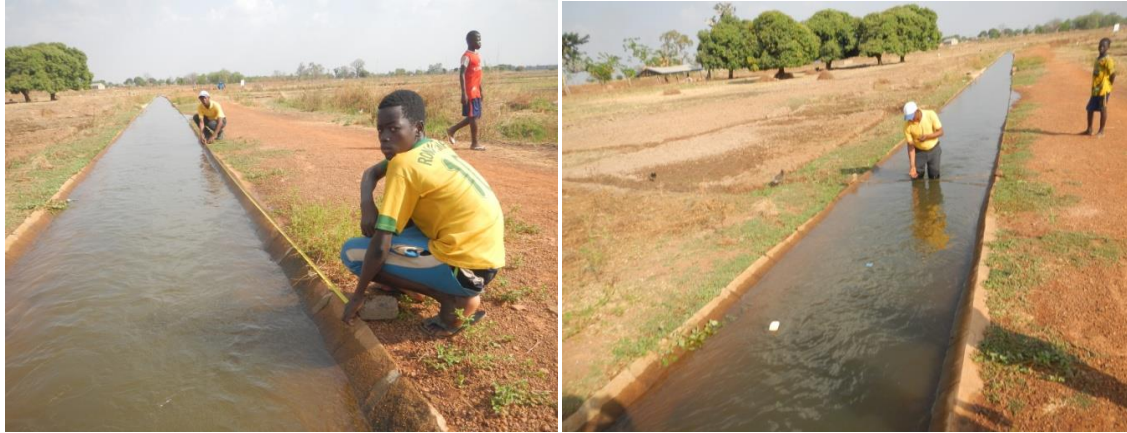
**Plate 3.2: Measurement of Flow Velocity in Main Canal by Float Method**

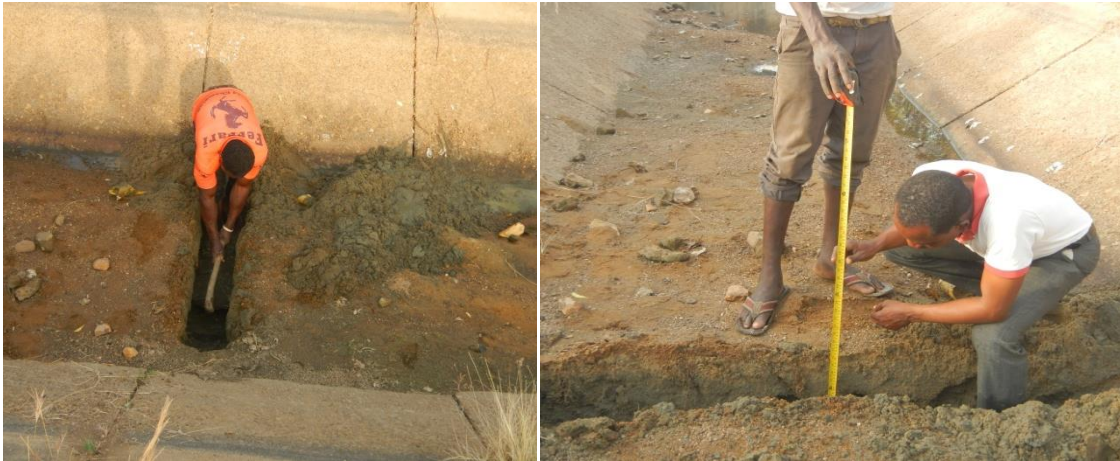
**Plate 3.3: Profile Digging and Measurement of Depth of Sediments in a Main Canal**

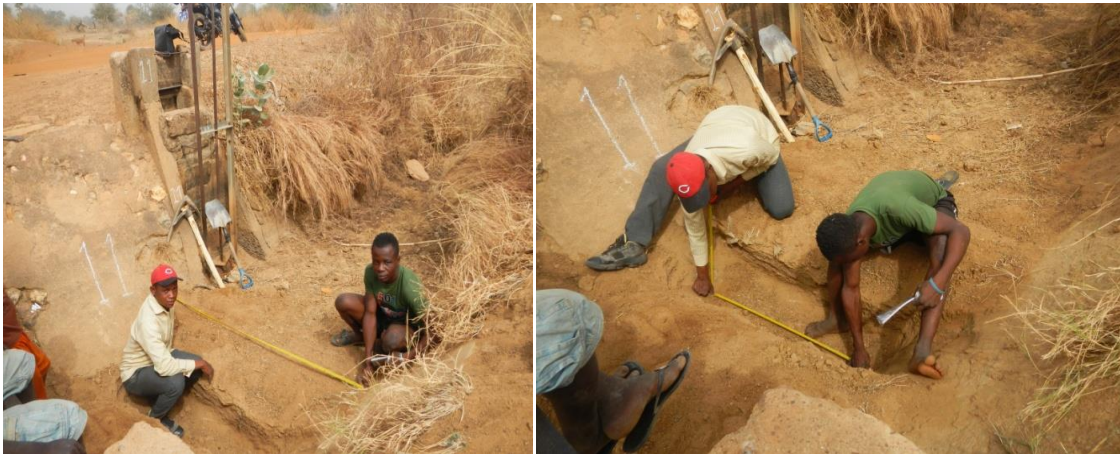
**Plate 3.4: Measurement of Top Width in Contact with Sediments and Bottom Width in a Main Canal**

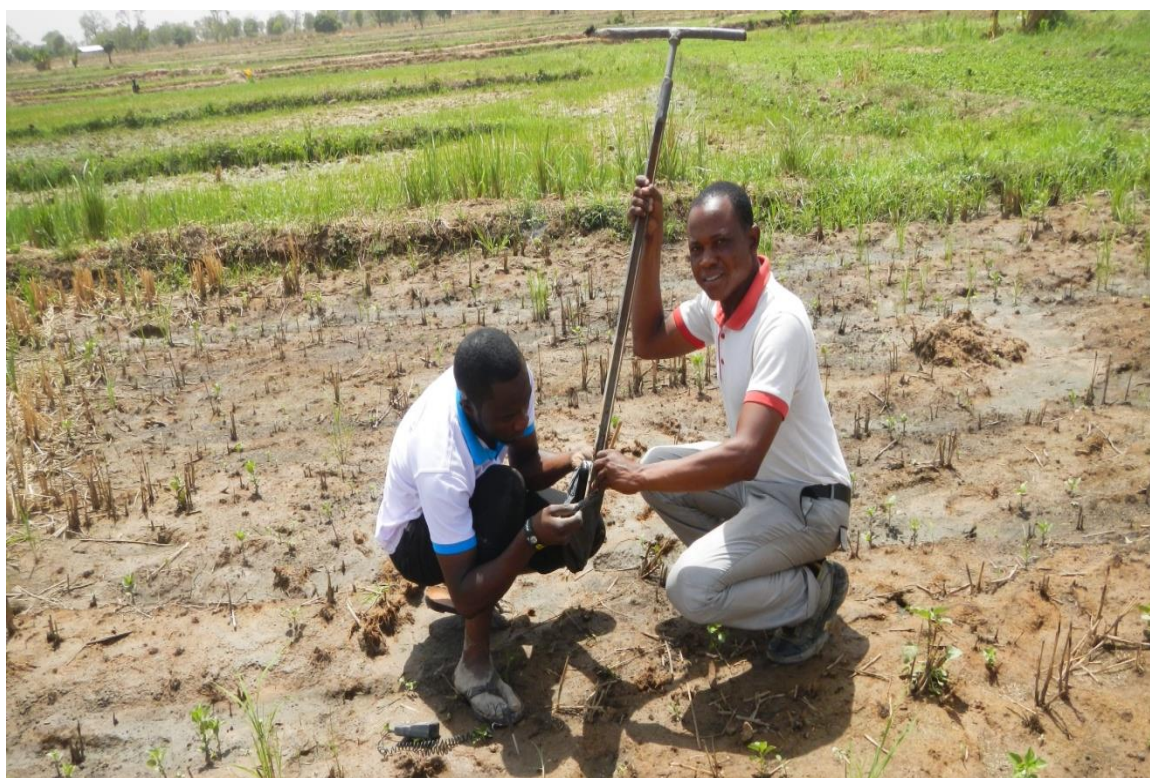
**Plate 3.5: Field Soil Sampling Using Auger**

at the point locations presented in Table 3.1. The samples were analysed at the Savannah Agricultural Research Institute Soil Science Laboratory in Nyankpala for pH, electrical conductivity (salinity), exchangeable sodium percentage (sodicity) and texture. pH was determined using 1:2.5 H<sub>2</sub>O dilution method. The levels of salinity were determined by measuring the electrical conductivity (EC) of a solution extracted from a soil wetted to a saturation paste (Senon *et al.*, 2012). The exchangeable sodium percentage (ESP) procedure was used to determine the levels of sodicity in the soils (Senon *et al.*, 2012). Plate 3.5 illustrates soil sampling with an auger in the field.

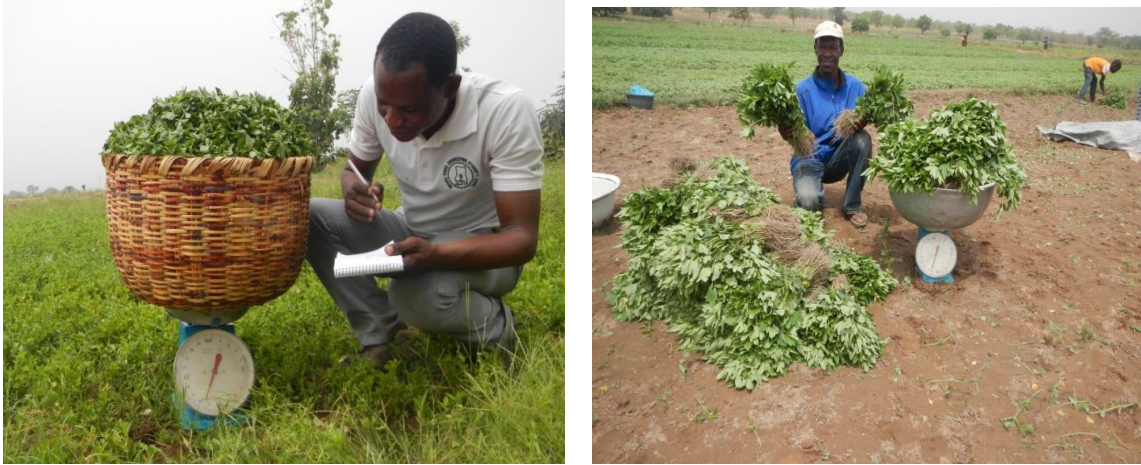
**Plate 3.6: Determination of Vegetables Yield in the Field**

Crop yields per unit area irrigated were obtained from farmers and the scheme managers. However, yields of leafy vegetables mainly roselle (*Hibiscus sabdariffa*) and ‘vegetable jute’ (*Corchorus olitorius*) in tonnes per unit area cropped were obtained using the *in-situ* crop cutting method (Tanton, 1987; Ijir, 1994). This method was carried out on a sample of randomly selected farms at Libga and Golinga for the determination of yields of the crops at harvest time (Plates 3.6).

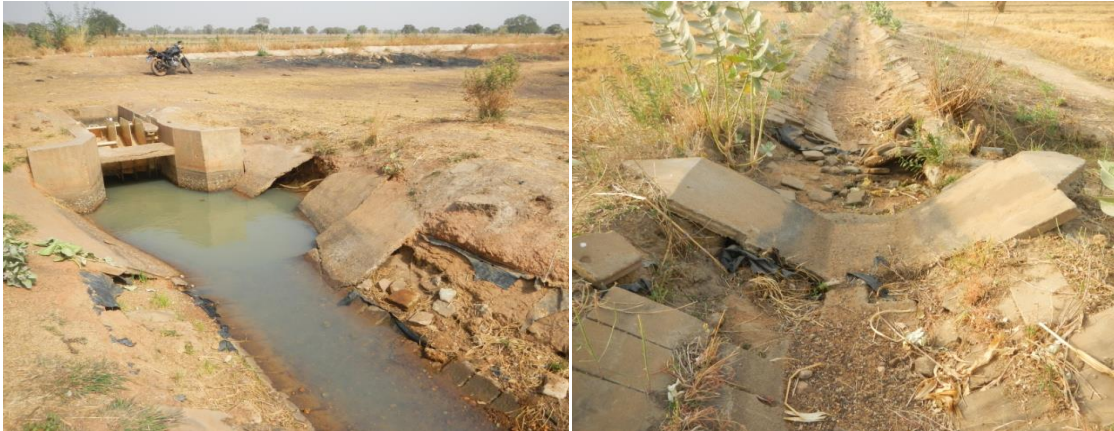
**Plate 4.1: Conditions of Laterals in Tono Irrigation Scheme**

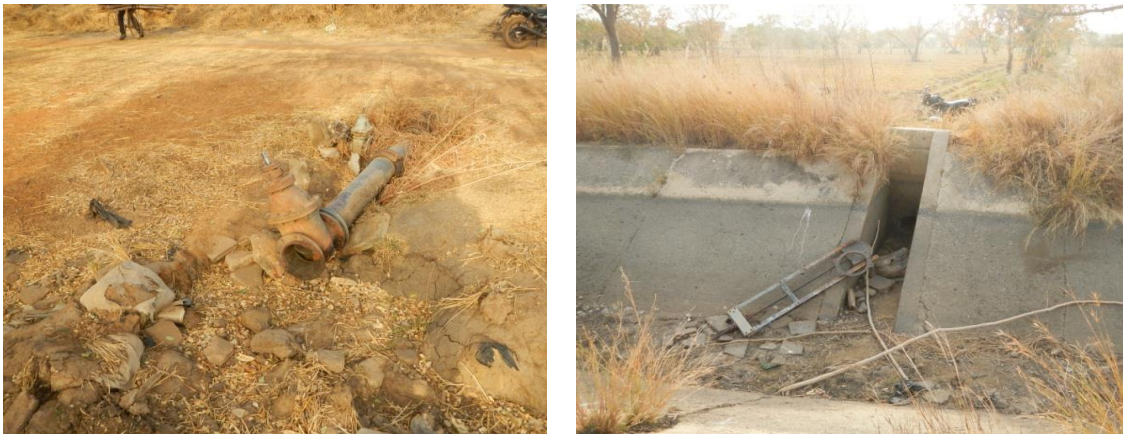
**Plate 4.2: Exposed and Broken Lateral Pipes in Tono Irrigation Scheme**

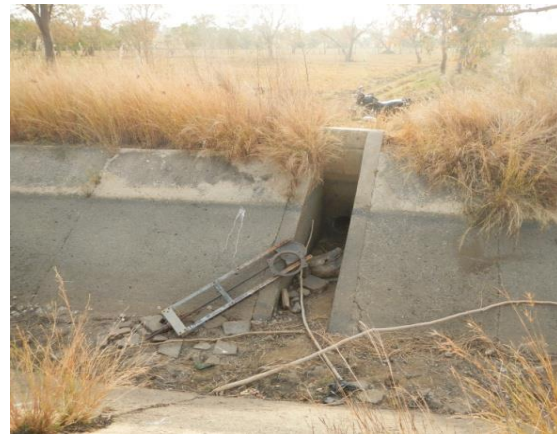
**Plate 4.3: Broken Lateral Gates in Tono Irrigation Scheme**

grasses, sand bags or mud as lateral gates to regulate flow in their fields. In a similar study, Ijir (1994) reported that 89 % of the structures of the Wumo Irrigation Scheme in Nigeria were in poor conditions and therefore operating ineffectively.

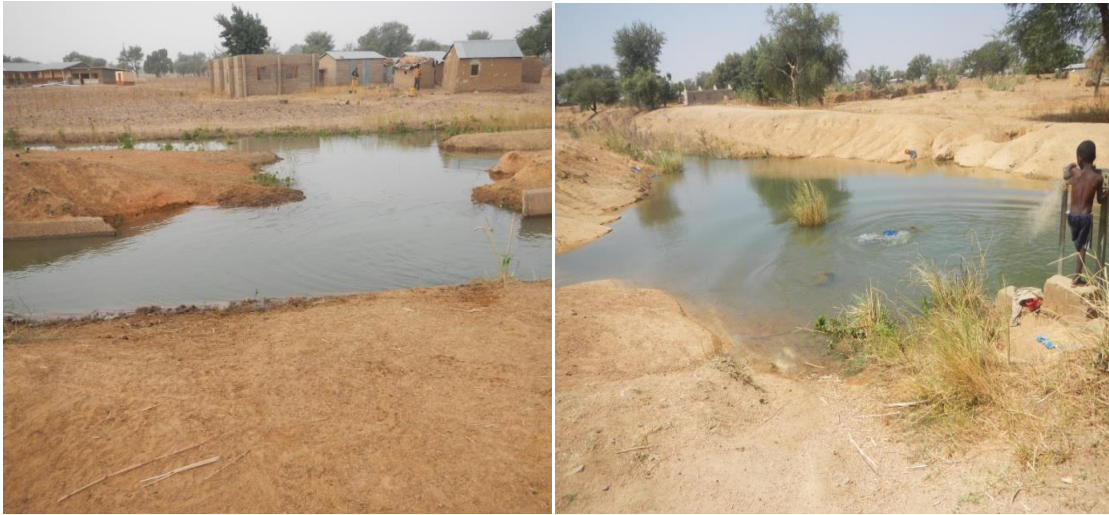
**Plate 4.4: Conditions of Main Canals in Vea Irrigation Scheme**

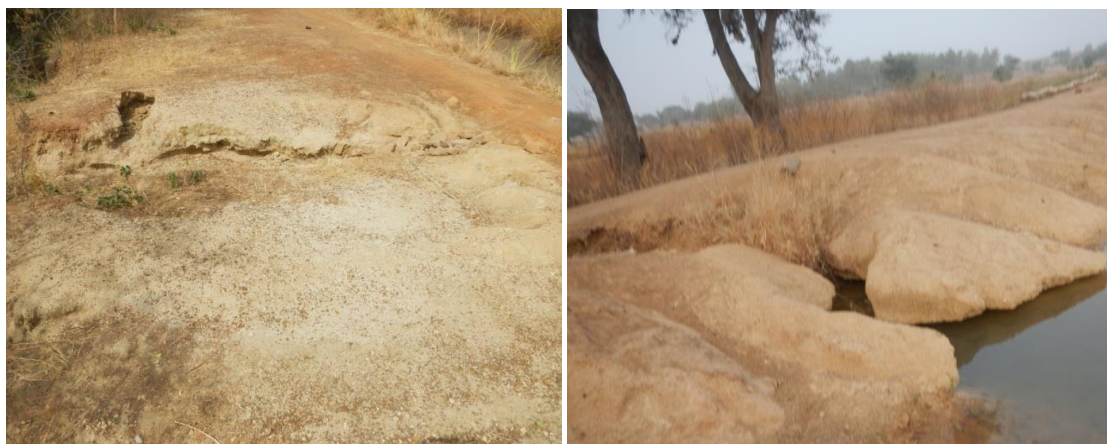
**Vea Irrigation Scheme:** The scheme recorded 53 % efficiency of roads passability. The results revealed that the road network was in a poor state. Approximately half of the total length of the road network within the scheme was not motorable especially in the rainy season. These stretches of the road network were eroded leaving visible gullies as illustrated in Plate 4.5.

**Plate 4.5: Condition of Canals Inspection Road Network in Vea Irrigation Scheme**

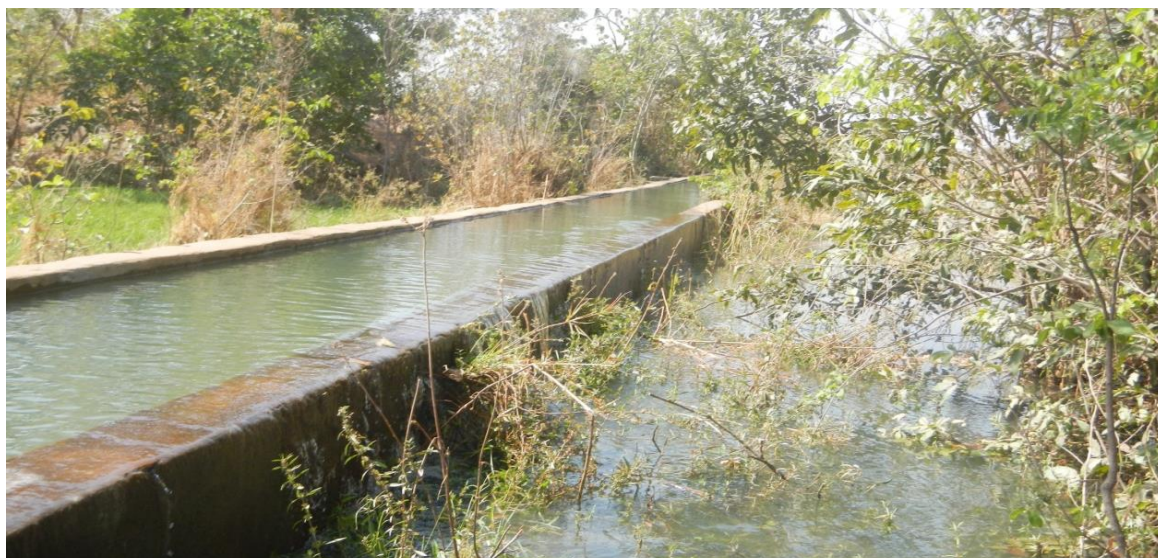
As a result of the poor state of the canals and laterals, most farmers resorted to lifting water from the main drain using pumps for irrigation, so the water bailiff deliberately opened the water to spill-over the canal banks (Plate 4.6) and subsequently flow to the main drain for such farmers to use. This practice consequently caused waterlogging in some fields.

**Plate 4.6: Spillage from Canal Causing Waterlogging in the Veia Irrigation Scheme**

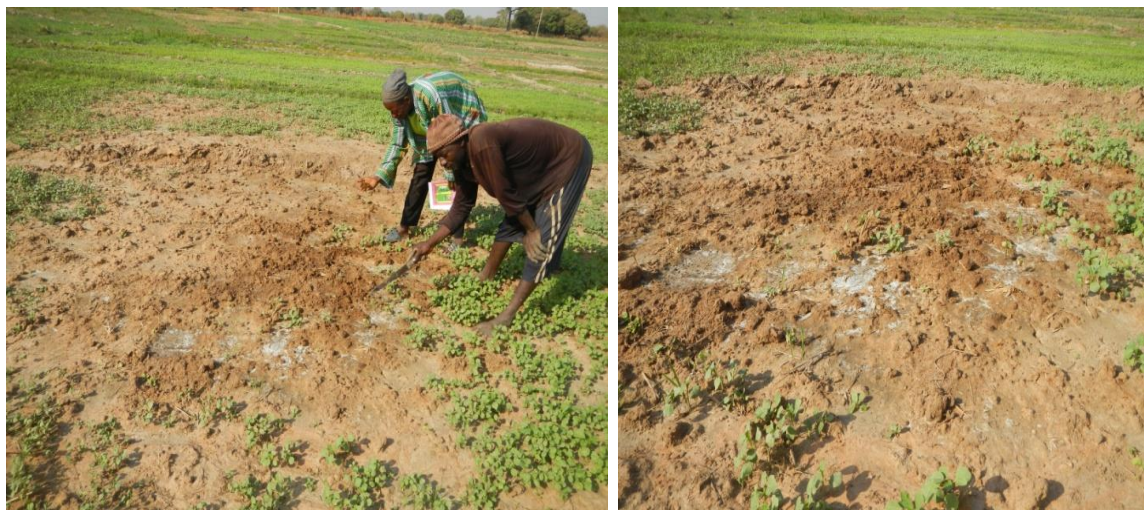
indicates that most high salt tolerant plants such as grain sorghum and maize will show injury and low/moderate salt-sensitive plants such as rice, onion, tomato, pepper, cabbage and okra will show severe injury including stunting, chlorosis and severe dwarfism (Igartua *et al.*, 1994; Krishnamurthy *et al.*, 2007). As a result of salinity in substantial quantities, moderately salt tolerance crops like tomato, cabbage, lettuce, carrot and onion were not cultivated on the scheme except roselle, jute mallow, okra, pepper and rice (Singh *et al.*, 2007). The 4,106  $\mu\text{S}/\text{cm}$  recorded at the Libga downstream is described as high which indicates that, the growth and yield of most low and moderately salt-sensitive crops like tomato, okra and vegetables can be severely affected. Plate 4.7 illustrates patches of land affected by salinity in Libga irrigation scheme.

**Plate 4.7: Salinity Affected Crop Fields at Libga Irrigation Scheme**

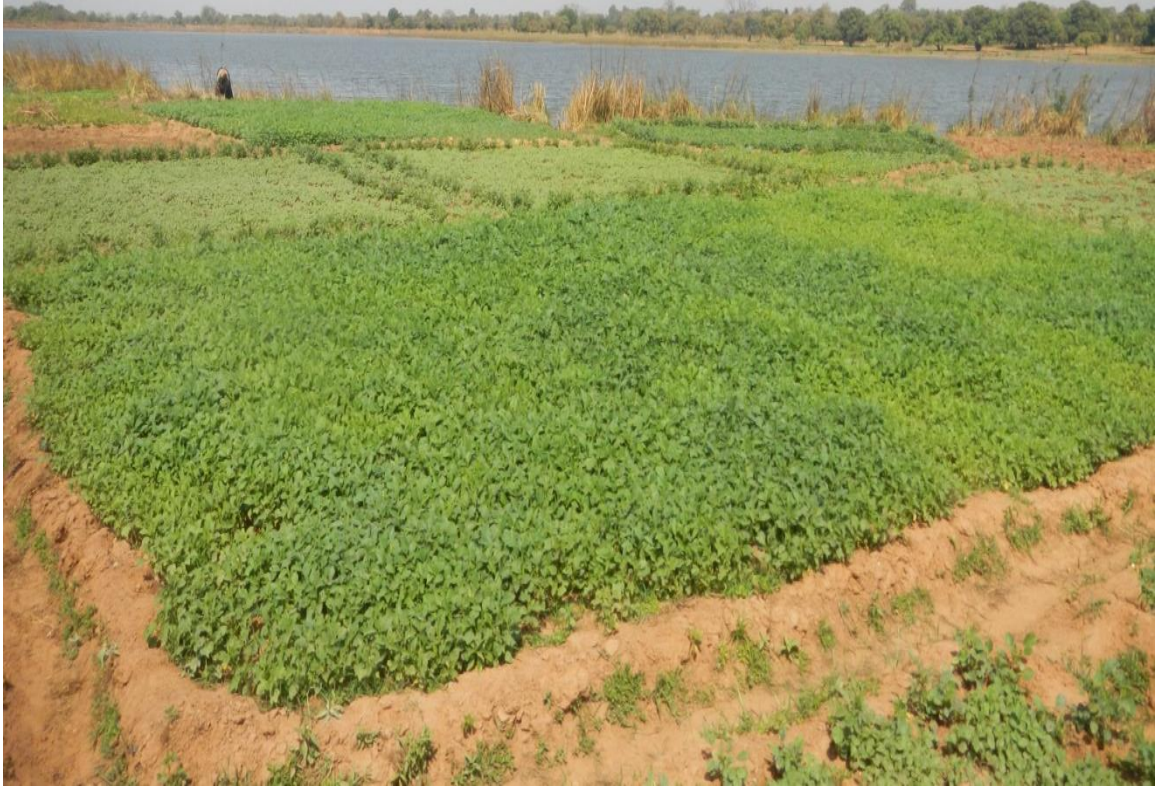
**Plate 4.8: Irrigated Farming at the Upstream of the Libga Reservoir**

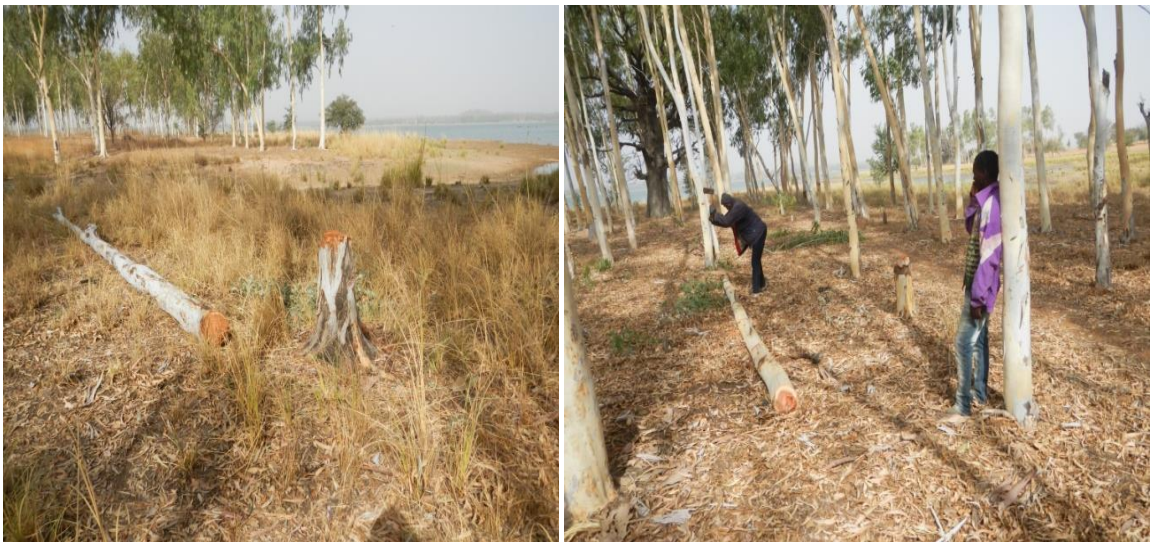
- **Felling of Trees Protecting the Reservoirs:** The *Eucalyptus spp* and *Cassia siamea* planted to check sediments from being carried into the reservoirs were felled by some people for logs, firewood and to make way for farming (Plate 4.9).

**Plate 4.9: Felling of Trees Protecting the Reservoir at Vea Irrigation Scheme**

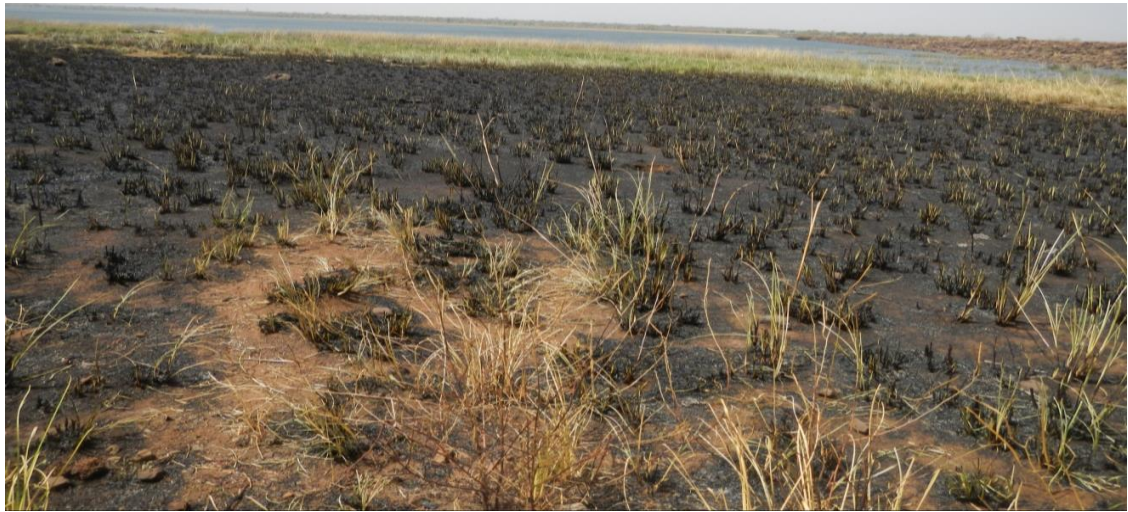
**Plate 4.10: Burnt Reservoir Protection Grasses at Bontanga Irrigation Scheme**

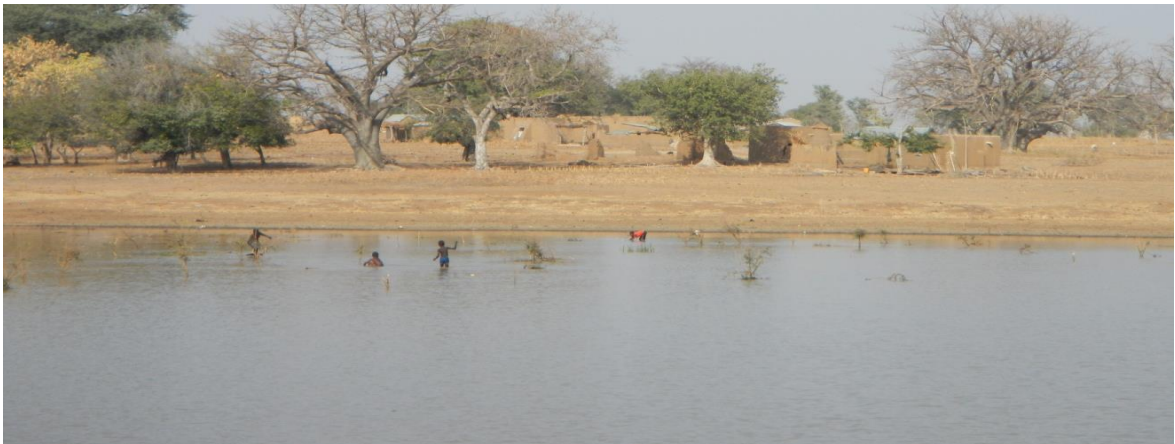
- **Encroachment by Human Settlements:** Human settlements were built too close to Doba's reservoir (Plate 4.11).

**Plate 4.11: Human Settlements Built too Close to the Doba Reservoir**

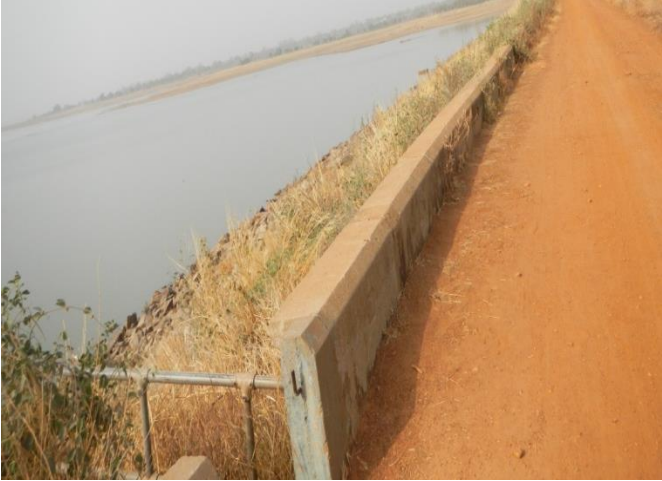
<ul style="list-style-type: none"> <li>• The 3.5 km long dam wall was in good working condition.</li> <li>• The upstream face was fully rip-raped with igneous rocks.</li> <li>• The wave wall had no defects.</li> <li>• The crest and downstream face were periodically regavelled.</li> </ul>
Vea

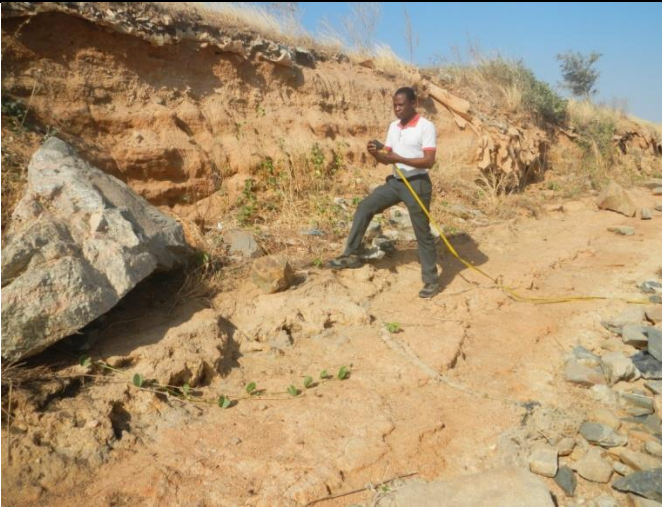
<ul style="list-style-type: none"> <li>• The 1.6 km long wall was in a very poor working condition.</li> <li>• The upstream slope had caved-in up to 21 metres towards the downstream slope due to poor stone rip-rapping.</li> <li>• Gullies were on the downstream slope.</li> <li>• The crest contained a lot of large potholes.</li> </ul>
Doba

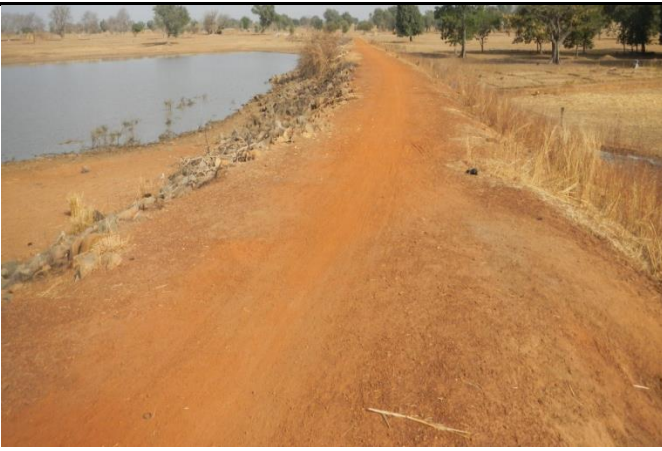
<ul style="list-style-type: none"> <li>• The 0.51 km long dam wall was in a poor working condition.</li> <li>• The downstream slope was severely eroded leaving gullies.</li> <li>• Water erosion had reduced the width of the crest.</li> <li>• Water erosion had reduced the height.</li> </ul>

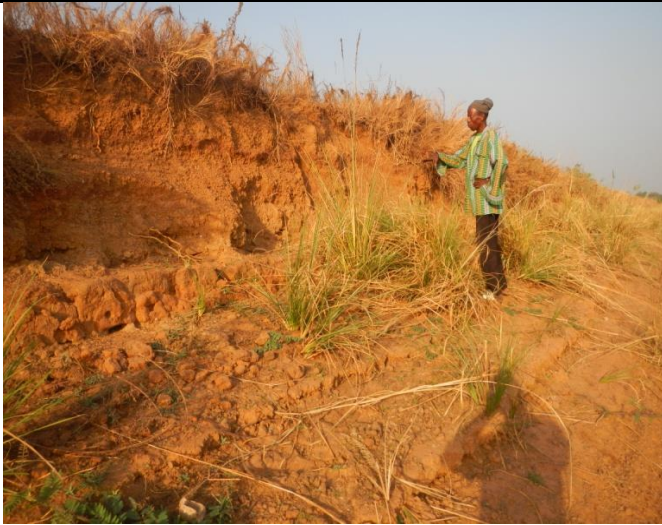
<ul style="list-style-type: none"> <li>• The 0.65 km long dam wall was in a very poor working condition.</li> <li>• The entire upstream slope had caved-in.</li> <li>• The downstream slope was severely eroded.</li> <li>• The crest contained a lot of large potholes.</li> <li>• Seepage through the wall was experienced in the rainy season.</li> <li>• The dam wall was at the verge of breaching.</li> </ul>
Bontanga

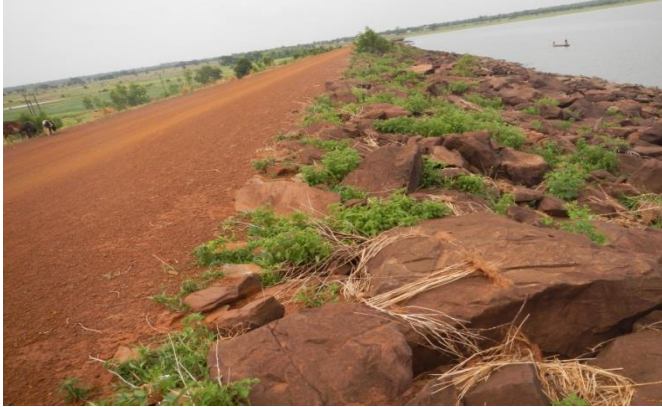
<ul style="list-style-type: none"> <li>• The 1.9 km long dam wall was in good working condition.</li> <li>• The upstream slope was fully rip-raped with igneous rocks.</li> <li>• The crest of the wall was in good condition.</li> <li>• The dam wall was rehabilitated by MiDA in 2011 – 2012.</li> </ul>
Golinga

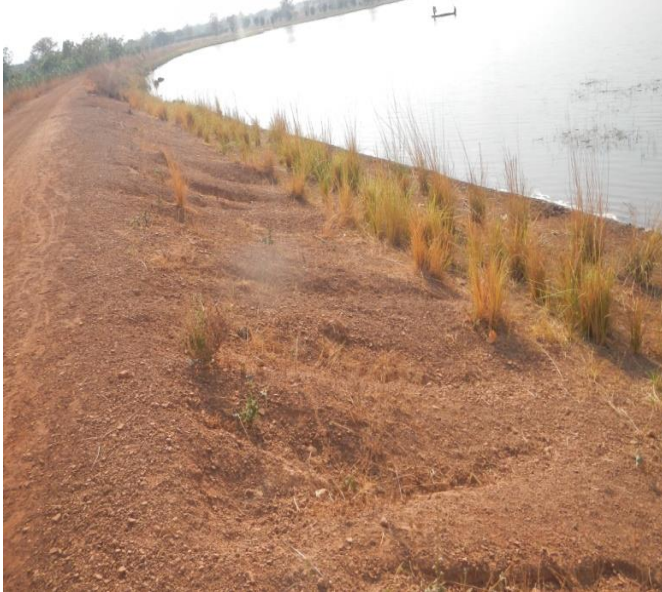
<ul style="list-style-type: none"> <li>• The 0.7 km long dam wall was in poor condition.</li> <li>• The upstream and downstream slopes were eroded. No stone rip-rapping.</li> <li>• There were potholes at some sections of the crest.</li> <li>• Erosion had reduced the height.</li> <li>• It was rehabilitated in 2011 – 2012, but degrading fast due to the poor rehabilitation.</li> </ul>

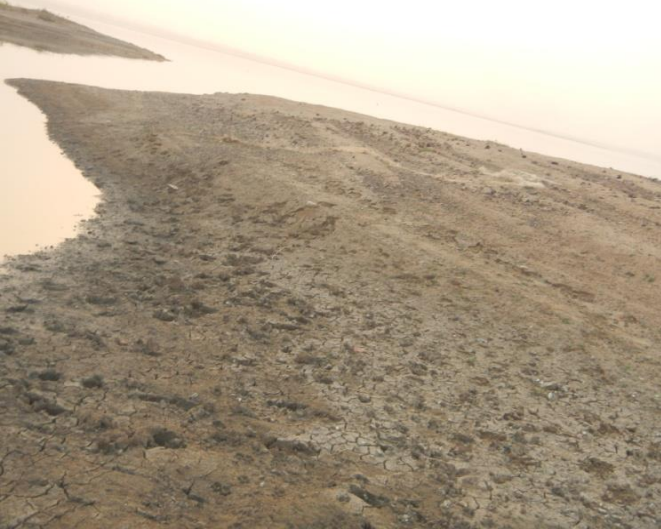
<ul style="list-style-type: none"> <li>• Contained considerable amounts of sediments.</li> <li>• The contributory factors include irrigated farming at the upstream of the reservoir and floods.</li> <li>• Water level at dead storage.</li> </ul>
Vea

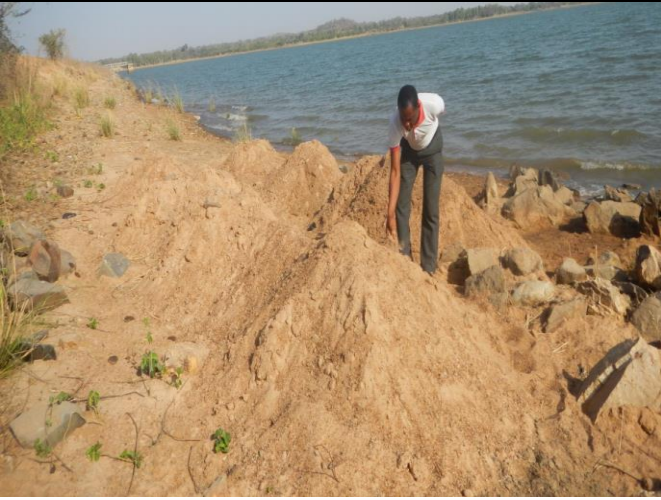
<ul style="list-style-type: none"> <li>• Contained high level of sediments.</li> <li>• The contributory factors include the irrigated farming at the upstream of the reservoir and floods.</li> <li>• The estimated average sedimentation of the reservoir was <math>1.4 \times 10^5</math> m<sup>3</sup>/year (Adongo <i>et al.</i>, 2014).</li> </ul>
Doba

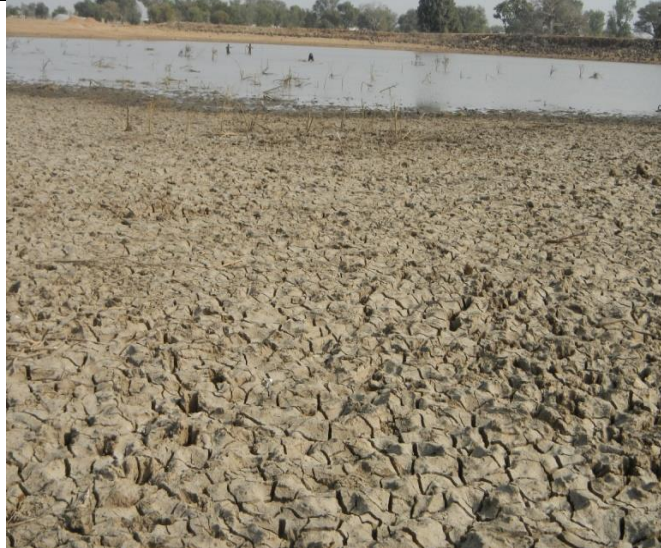
<ul style="list-style-type: none"> <li>• Silted and dried-up.</li> <li>• The contributory factors include low level of agricultural best management practices on the watershed, human settlement and poor vegetative cover.</li> <li>• No desiltation after 59 years of construction.</li> </ul>

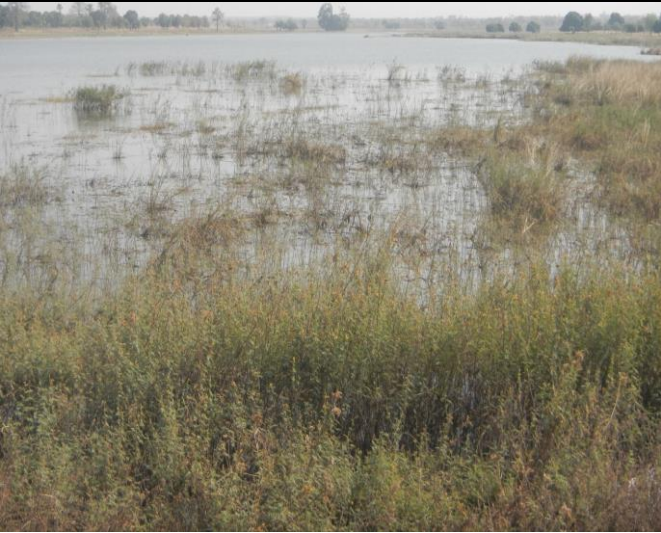
<ul style="list-style-type: none"> <li>• The reservoir contained high amounts of sediments and weeds.</li> <li>• No desiltation after 46 years of construction.</li> </ul>
Bontanga

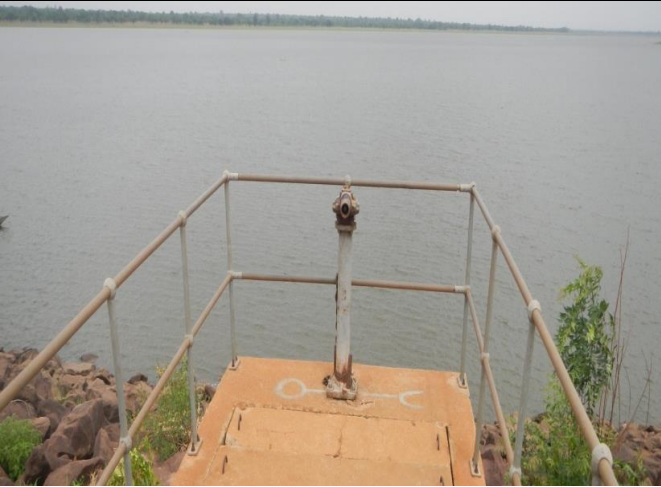
<ul style="list-style-type: none"> <li>• The reservoir was in good condition.</li> <li>• Contained some considerable amounts of sediments.</li> </ul>
Golinga

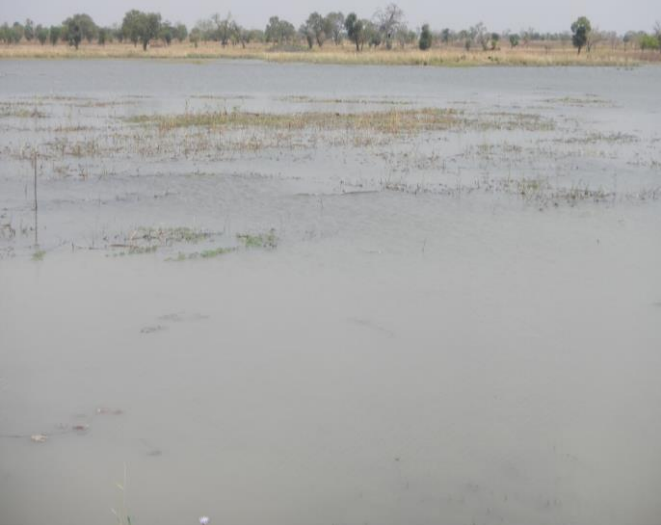
<ul style="list-style-type: none"> <li>• The reservoir contained high amounts of sediments and weeds.</li> <li>• The average siltation rate of the reservoir was 7.7 cm/y (SNC, 2010).</li> <li>• No desiltation after construction was completed in 1974.</li> </ul>

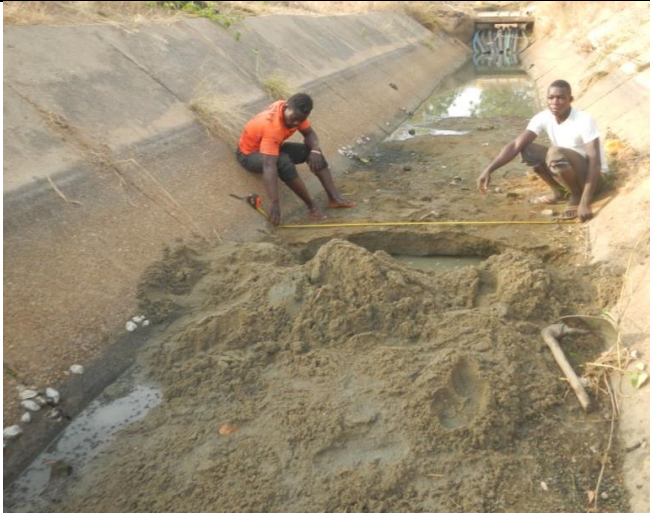
<ul style="list-style-type: none"> <li>• The 42 km long main canals had no breaches.</li> <li>• It was rehabilitated in 2008, where the two (2) canals were relined with concrete.</li> <li>• The canals had not been desilted since 2012. The sediments depth was 0.32 m.</li> <li>• Average volume of silt was 17,220 m<sup>3</sup>.</li> </ul>
Vea

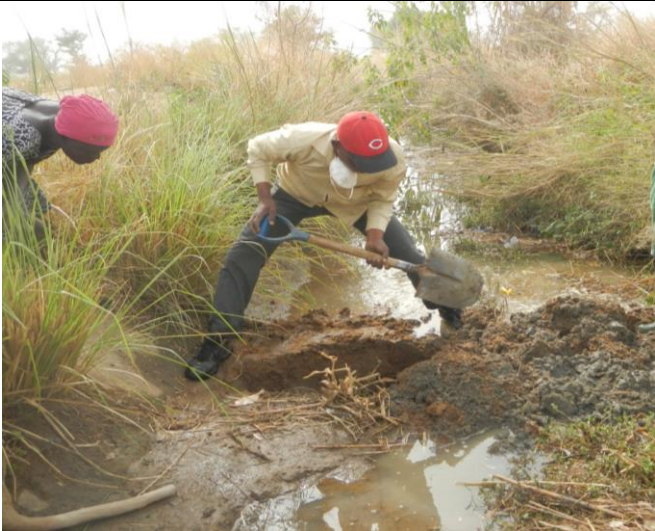
<ul style="list-style-type: none"> <li>• The two main canals, with a total length of 26.5 km long were breached at several sections, silted and full of weeds and shrubs.</li> <li>• The average depth of sediments in the canals was 0.47 m.</li> <li>• Average volume of sediments (silt) in the canals was 20.670 m<sup>3</sup>.</li> </ul>
Doba

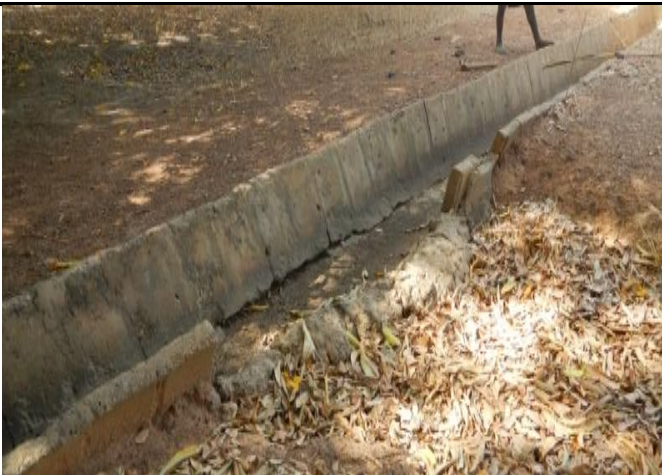
<ul style="list-style-type: none"> <li>• The 0.6 km long canal was breached at several sections due to animal crossing and improper practices of farmers.</li> <li>• The average depth of sediments in the canal was estimated to be 0.15 m.</li> <li>• Average volume of sediments was 24 m<sup>3</sup>.</li> </ul>

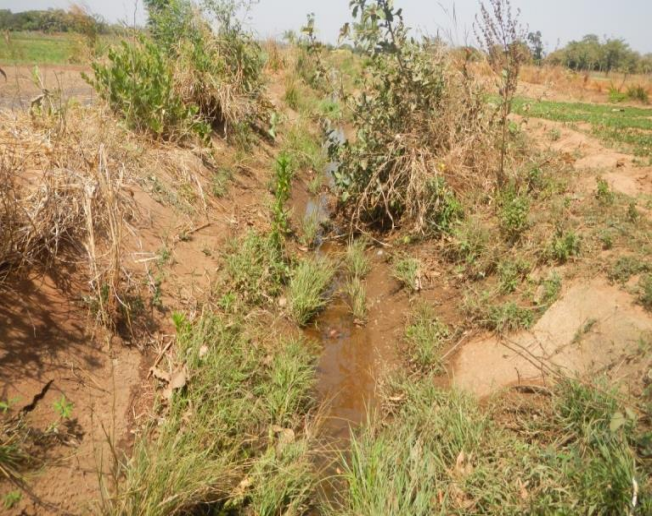
<ul style="list-style-type: none"> <li>• The 1.3 km long main canal was in a poor working condition.</li> <li>• It had several cracks and displaced slabs at some sections.</li> <li>• It was silted, weedy and contains considerable amounts of shrubs.</li> <li>• The flow length of the canal now stood at 1.15 km due to faulty construction.</li> </ul>
Bontanga

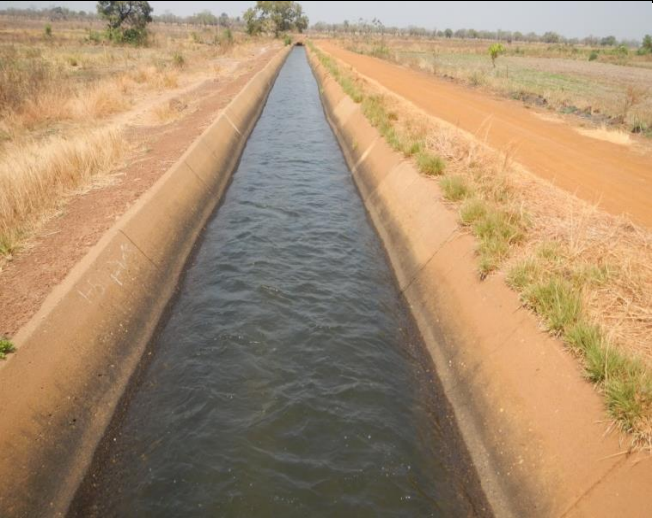
<ul style="list-style-type: none"> <li>• The 11.5 km long main canals were in good working condition.</li> <li>• No breaches, sediments and weeds were found in the canals.</li> <li>• The canals were rehabilitated in 2011 – 2012 by MiDA.</li> <li>• Cracks repaired as and when they occur.</li> </ul>
Golinga

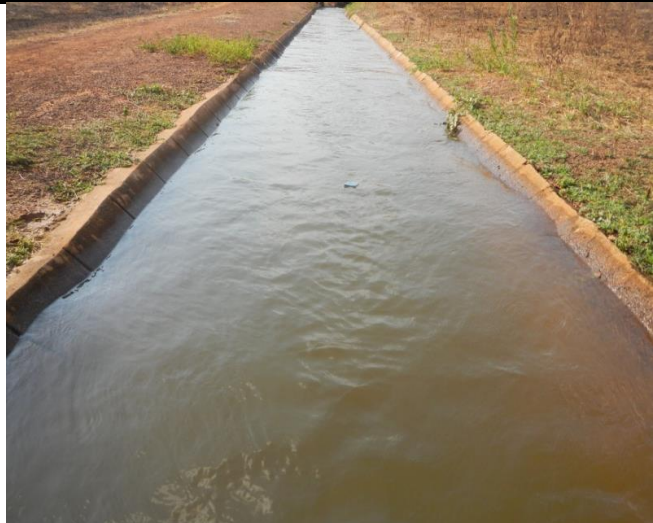
<ul style="list-style-type: none"> <li>• The 2.3 km long canals were in good working condition.</li> <li>• The canals were rehabilitated in 2011 – 2012 by MiDA.</li> <li>• No sediments were found.</li> </ul>

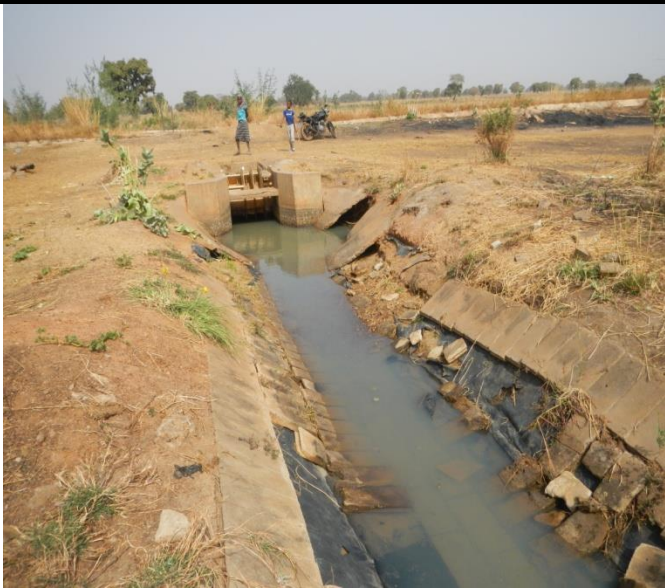
<ul style="list-style-type: none"> <li>• The 82 laterals with a total length of 56 km were in poor working condition.</li> <li>• They had never been rehabilitated since construction was completed in 1985.</li> <li>• The concrete slabs were displaced at several sections and control gates broken.</li> <li>• The condition of the laterals resulted in waste of irrigation water through seepage.</li> </ul>
Vea

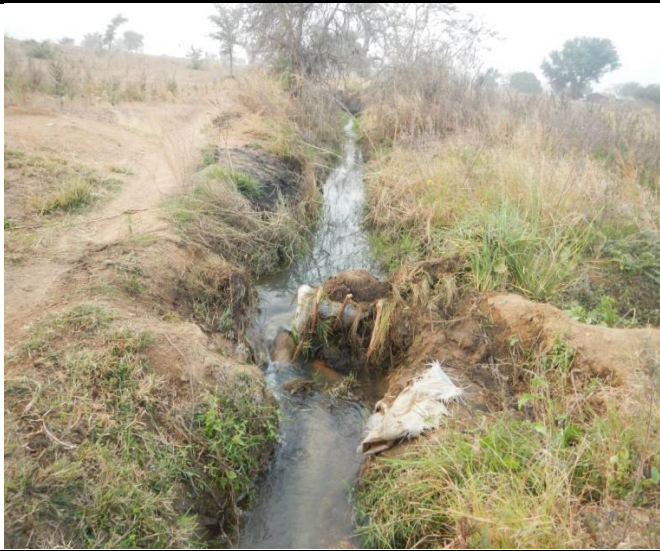
<ul style="list-style-type: none"> <li>• The 60 laterals were in poor working condition.</li> <li>• They had never been rehabilitated since construction was completed in 1980.</li> <li>• All the laterals had their concrete slabs, check structures and control gates removed.</li> <li>• The condition resulted in waste of irrigation water through seepage.</li> </ul>
Doba

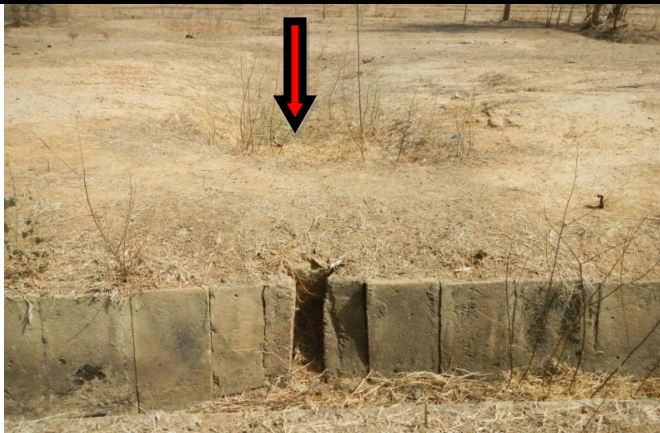
<ul style="list-style-type: none"> <li>• All the 10 laterals on the scheme were silted-up beyond recognition.</li> <li>• All the lateral gates were removed.</li> <li>• The arrow shows the position of the lateral.</li> </ul>

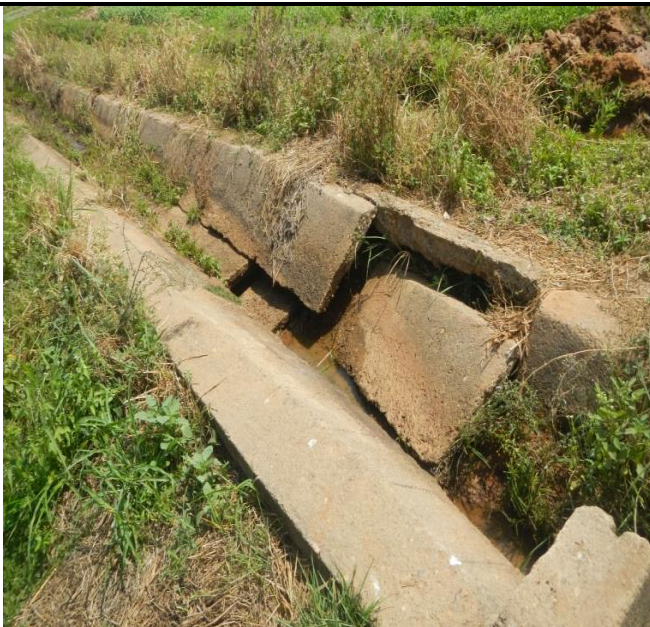
<ul style="list-style-type: none"> <li>• The 8 laterals were in poor working condition.</li> <li>• Each lateral was breached at several sections despite the rehabilitation in 2008.</li> <li>• Two (2) of the laterals at the tail-end were presently not functioning due to faulty construction of the main canal.</li> <li>• The condition resulted in seepage and waterlogging in the scheme.</li> </ul>
Bontanga

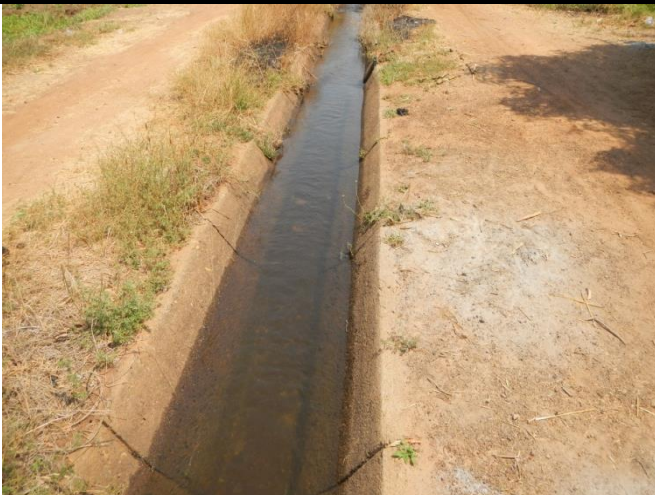
<ul style="list-style-type: none"> <li>• The 28 laterals were in good working condition.</li> <li>• There were no breaches and are free of sediments and weeds.</li> <li>• They were rehabilitated in 2011 – 2012 by MiDA.</li> <li>• Cracks repaired as and when they occur.</li> <li>• Check structures were working properly.</li> </ul>
Golinga	 	<ul style="list-style-type: none"> <li>• All the 12 laterals were in good working condition. No cracks, sediments and weeds.</li> <li>• They were rehabilitated in 2011 – 2012 by MiDA.</li> <li>• Some lateral and check structure gates had been stolen.</li> </ul>

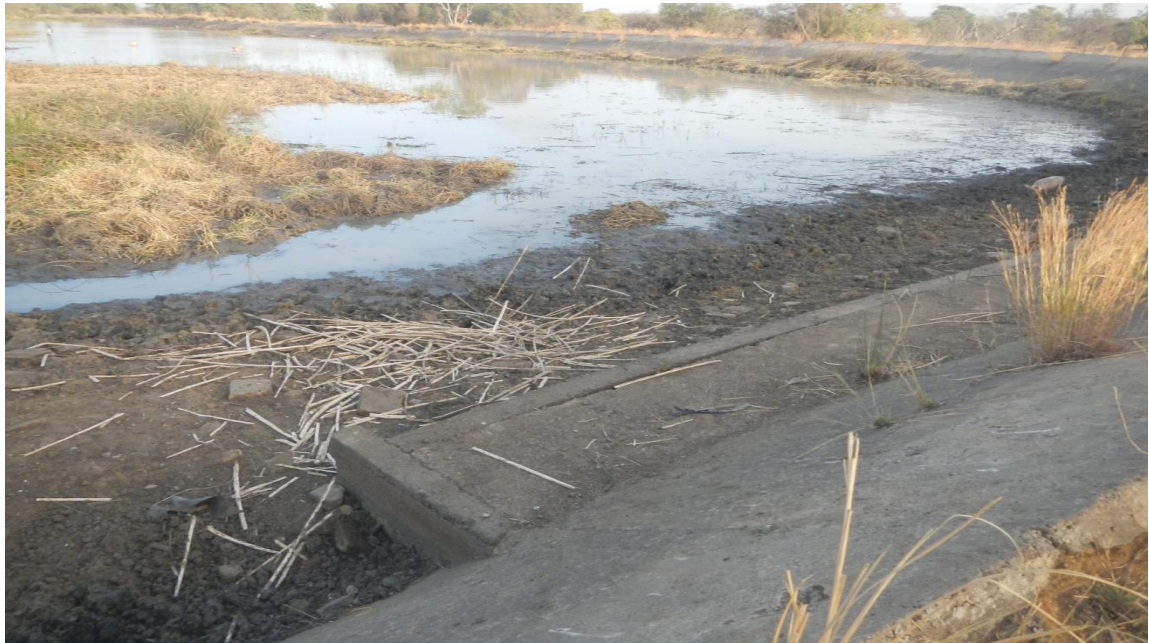
**Plate 4.12: Silted and Weedy Night Storage Reservoir in Tono Irrigation Scheme**

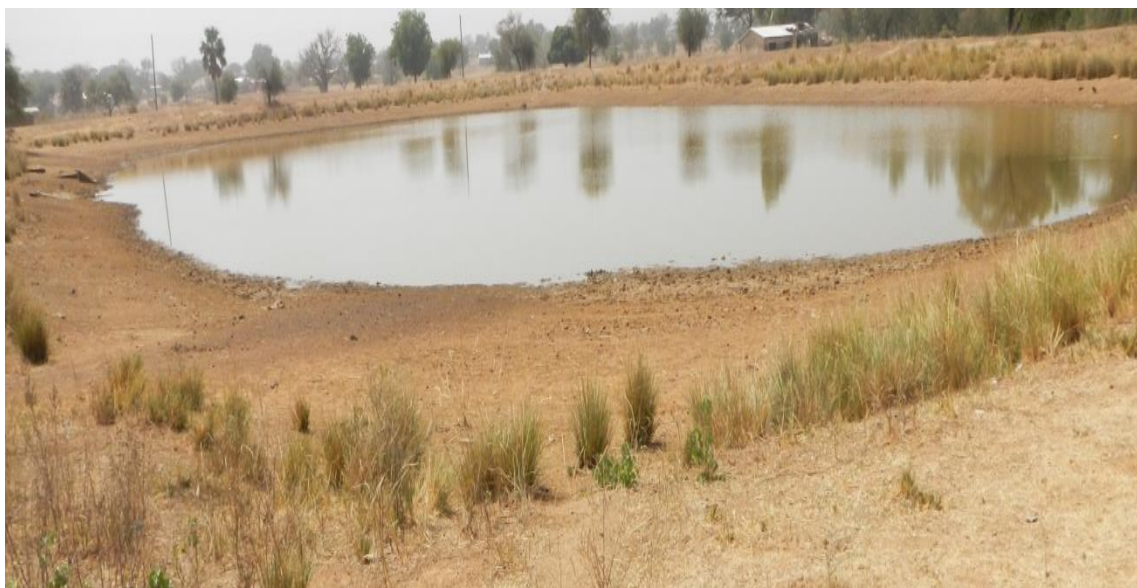
**Plate 4.13: Silted Night Storage Reservoir in Vea Irrigation Scheme**

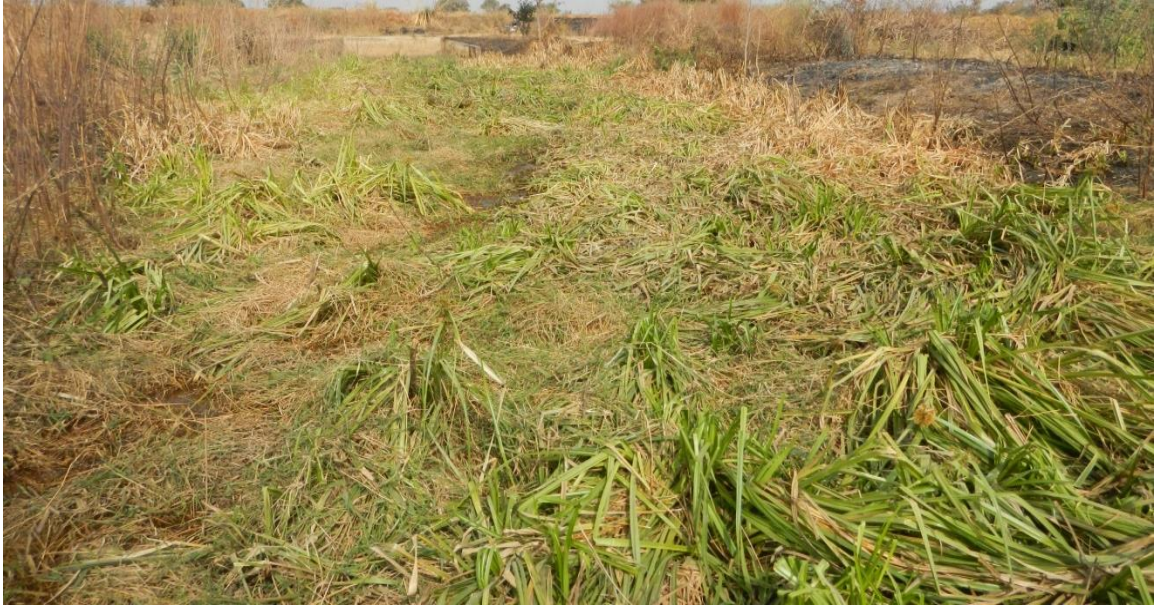
**Plate 4.14: Silted and Weedy Primary Drain of the Tono Irrigation Scheme**
