**PERFORMANCE ASSESSMENT OF IRRIGATION SCHEMES IN NORTHERN  
GHANA USING COMPARATIVE PERFORMANCE INDICATORS**

**A THESIS SUBMITTED TO THE DEPARTMENT OF AGRICULTURAL  
MECHANISATION AND IRRIGATION TECHNOLOGY, FACULTY OF  
AGRICULTURE IN PARTIAL FULFILMENT OF THE REQUIREMENTS FOR  
THE AWARD OF MASTER OF PHILOSOPHY DEGREE IN SOIL AND WATER  
CONSERVATION AND MANAGEMENT**

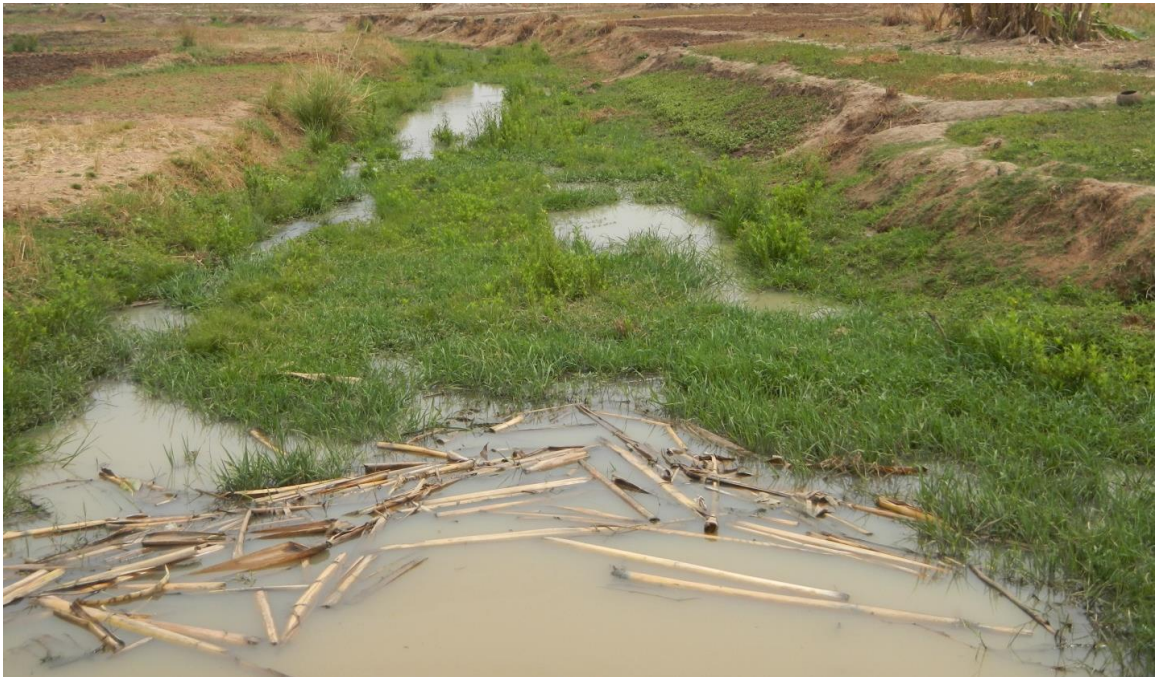
**Plate 4.15: Silted and Weedy Main Drain of the Golinga Irrigation Scheme**

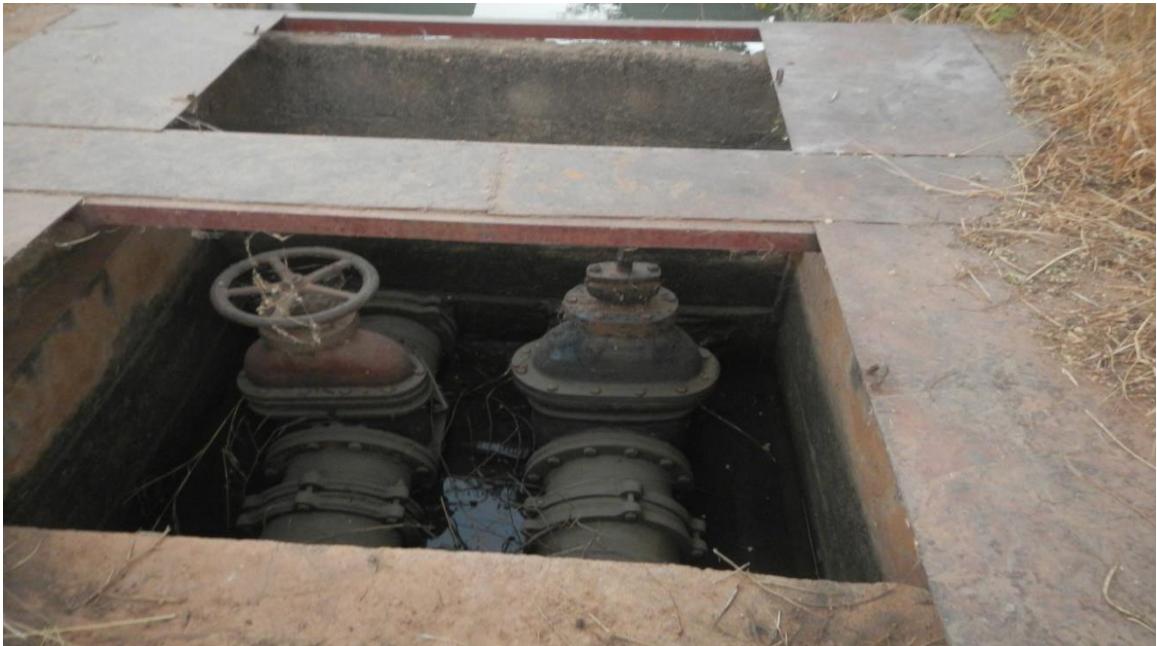
**Plate 4.16: Defunct Off-take Valves in Vea Irrigation Scheme**

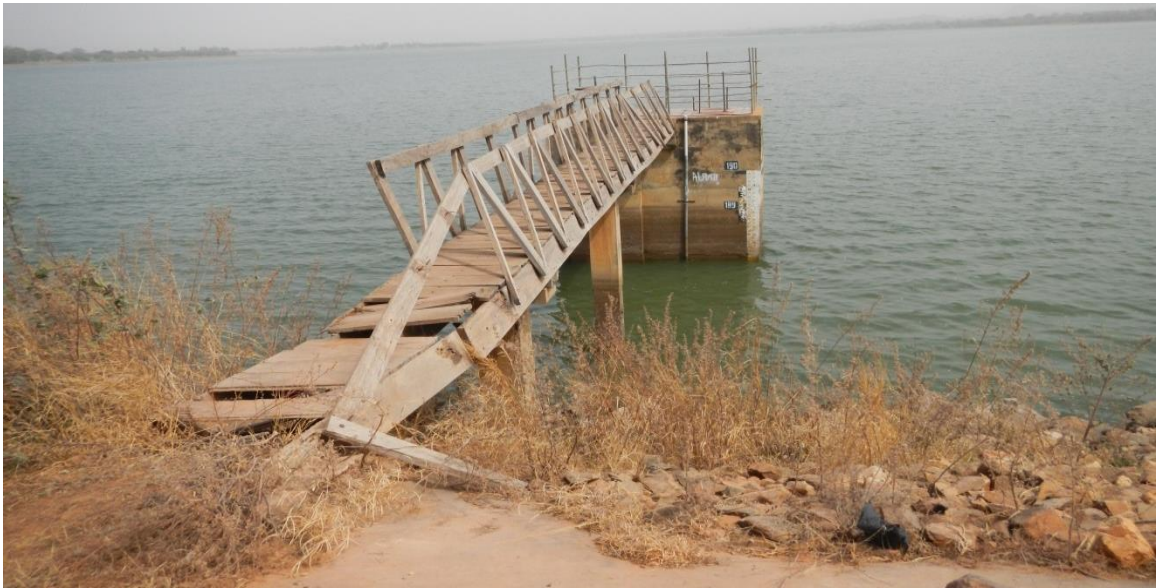
**Plate 4.17: Condition of Walk-Way to Off-take Valves in Vea Irrigation Scheme**

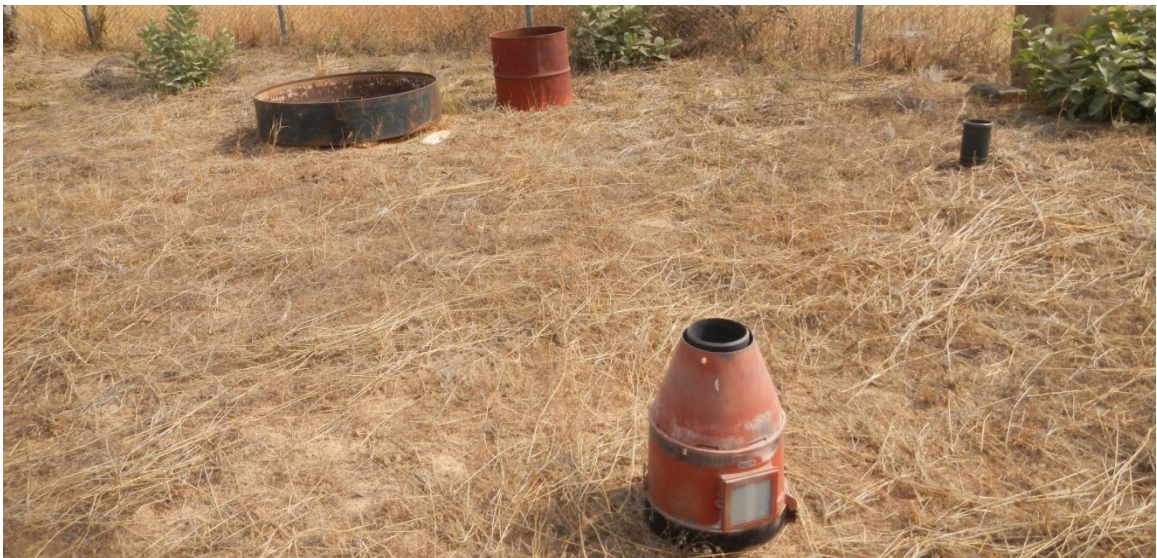
instruments, the station became defunct in 2008. Presently, in the station were corroded evaporation pan, sunshine drum, rain gauges, sunshine recorder, rotten and empty Stevenson screen and defunct anemometer and wind vane (Plate 4.18).

**Plate 4.18: Meteorological Station in the Tono Irrigation Scheme**

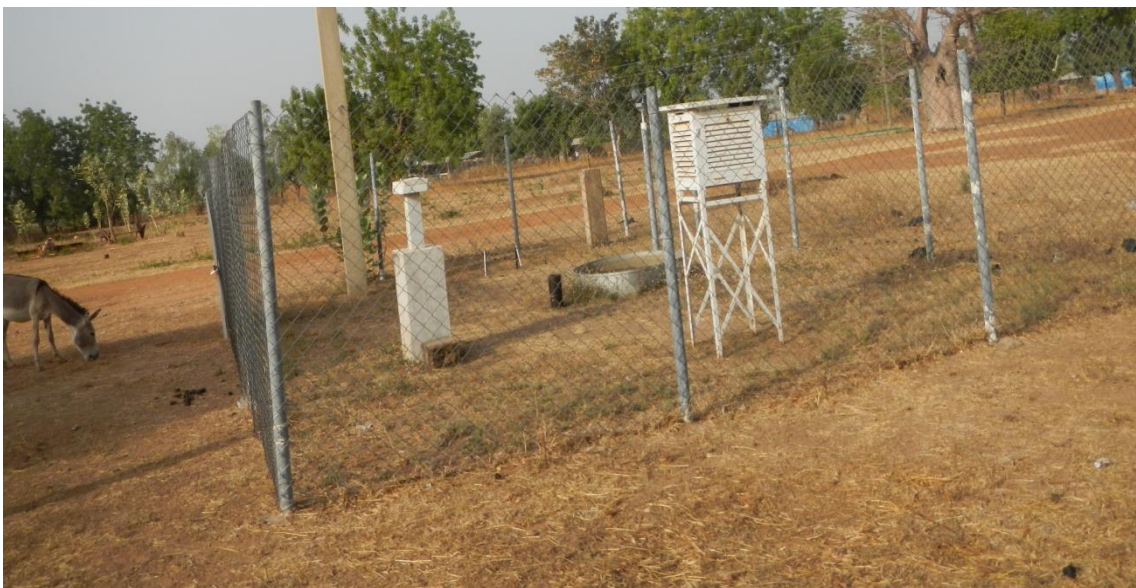
The meteorological station situated at the Veia irrigation scheme belongs to the Ghana Meteorological Agency - Bolgatanga. The station was in good working condition as illustrated in Plate 4.19. It provides all climatic data to the Veia scheme at no cost.

**Plate 4.19: Meteorological Station in the Veia Irrigation Scheme**

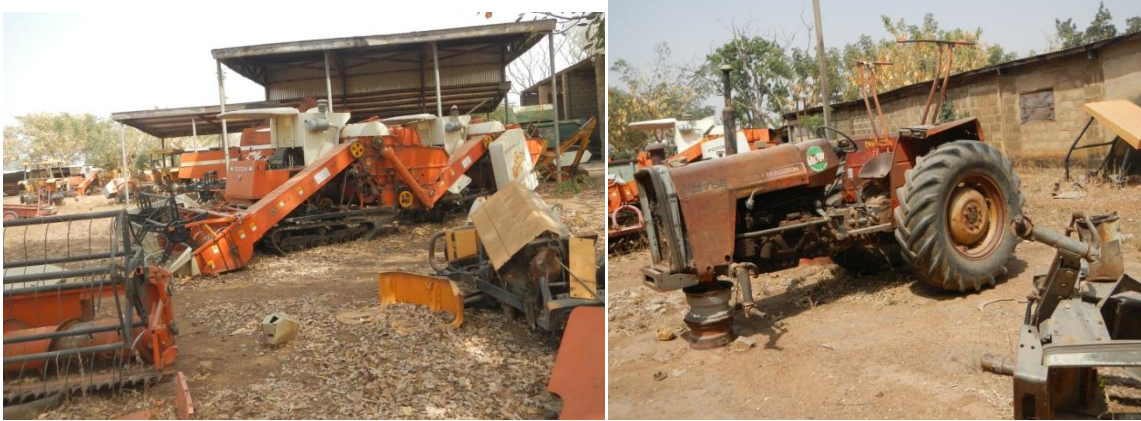
**Tono Irrigation Scheme:** The scheme has 12 motorcycles, which have been distributed to the extension and irrigation staff. The only pick – up for the scheme was used by the Scheme Manager. It was in good working condition. As presented in Table 4.26 and illustrated in Plate 4.20, the scheme had several farm equipment and implements, but almost all were in defunct condition as a result of worn-out parts, broken parts or outlived lifespan. The workshop was also not functioning as there were no farm equipment and implements for repairs and maintenance even though there were skilled personnel for maintenance.

**Plate 4.20: Farm Equipment and Implements in the Tono Irrigation Scheme**

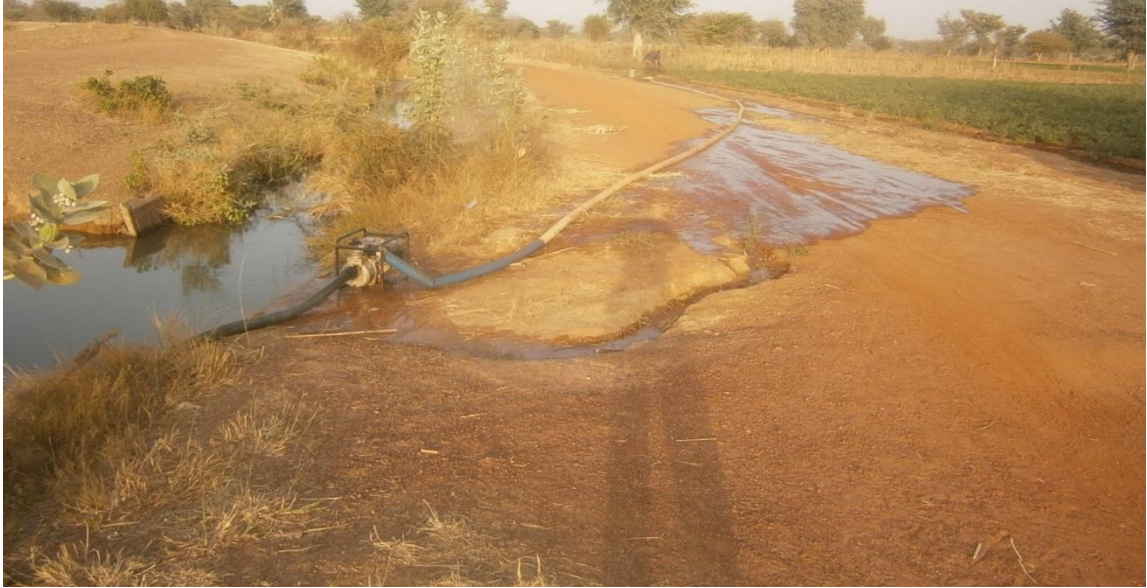
**Plate 4.22: Lifting Water from Canal Using Water Pump in theVea Irrigation Scheme**

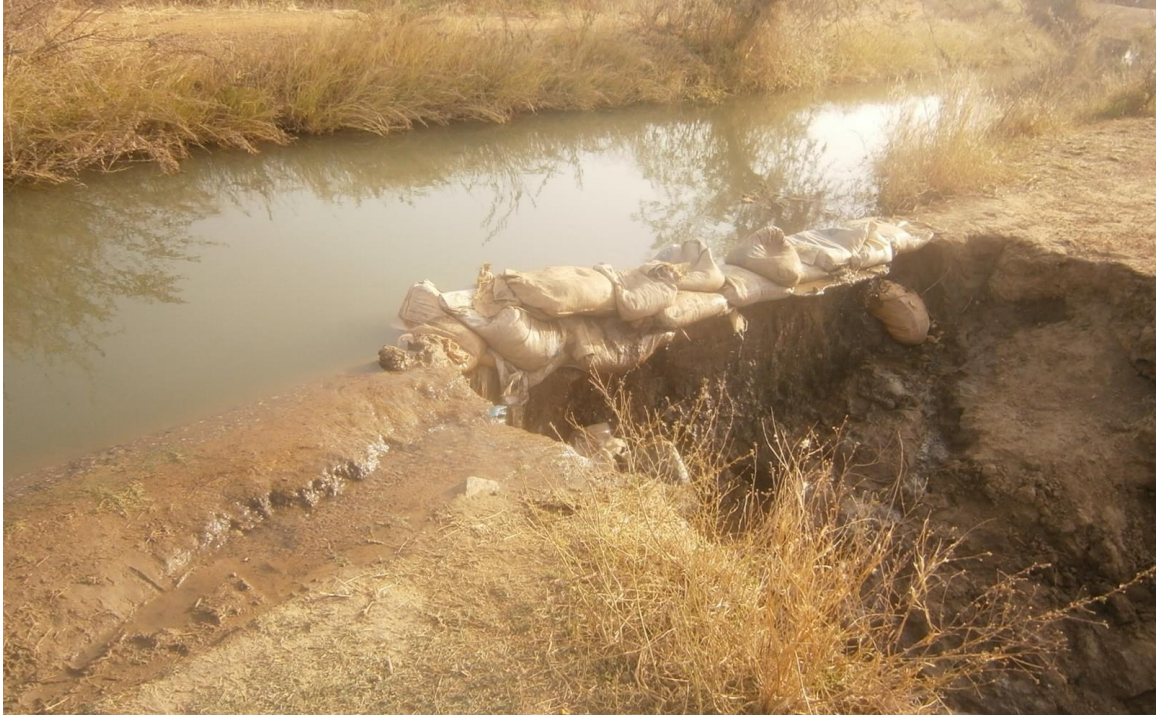
**Plate 4.23: Breached Canal Temporarily Repaired With Sandbags by Farmers in the Vea Irrigation Scheme**

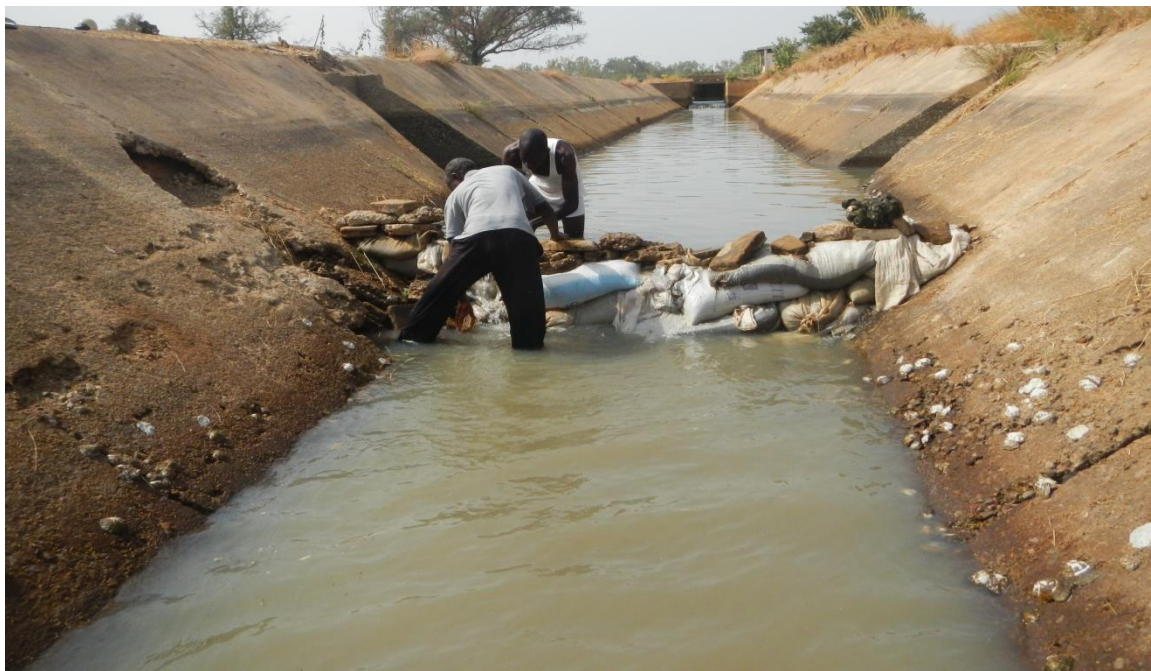
**Plate 4.24: Farmers Improvising Check Structure on a Canal Using Sandbags and Stones in the Tono Irrigation Scheme**

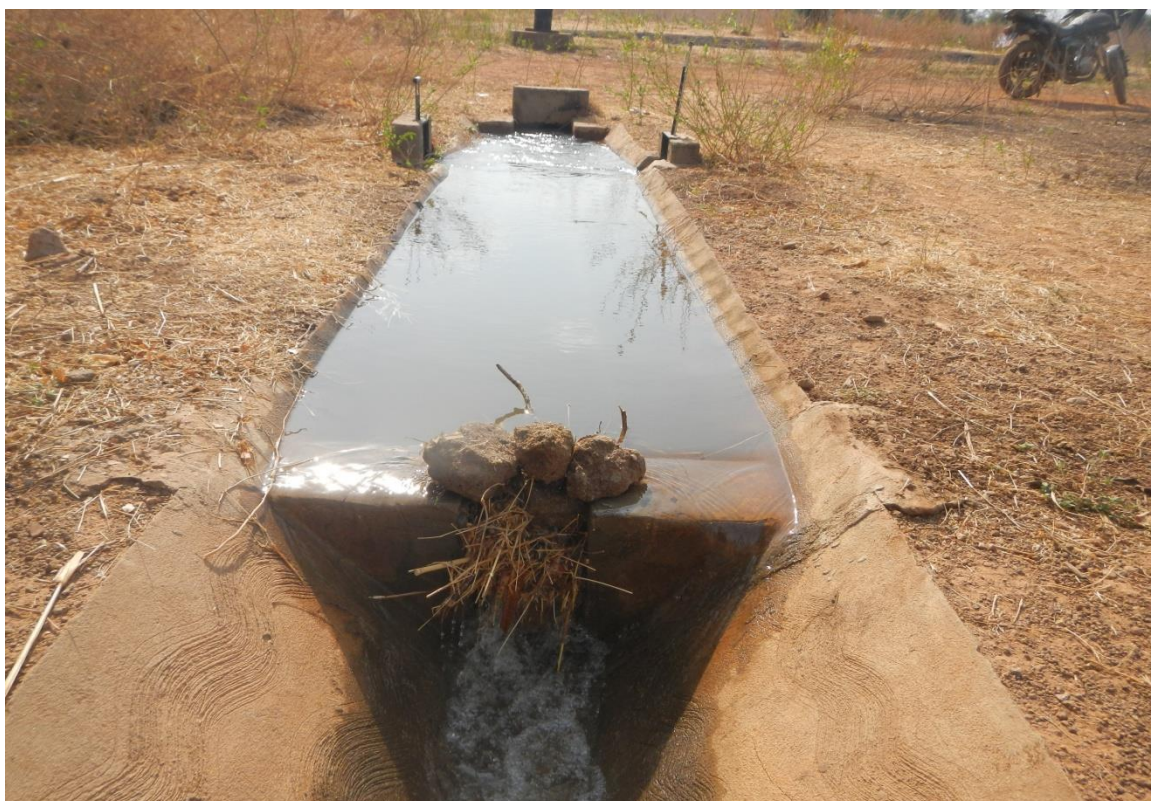
**Plate 4.25: Improvised Lateral Check Structure from Stones and Grass at Golinga**

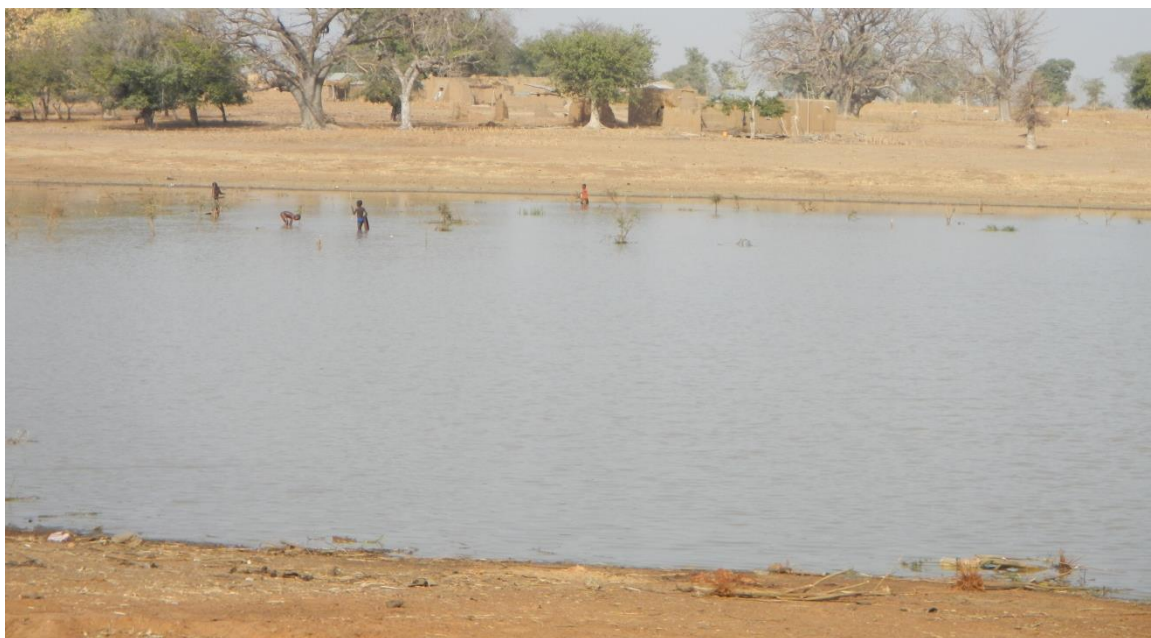
**Appendix A6: Human Settlements Built Very Close to the Doba Reservoir**

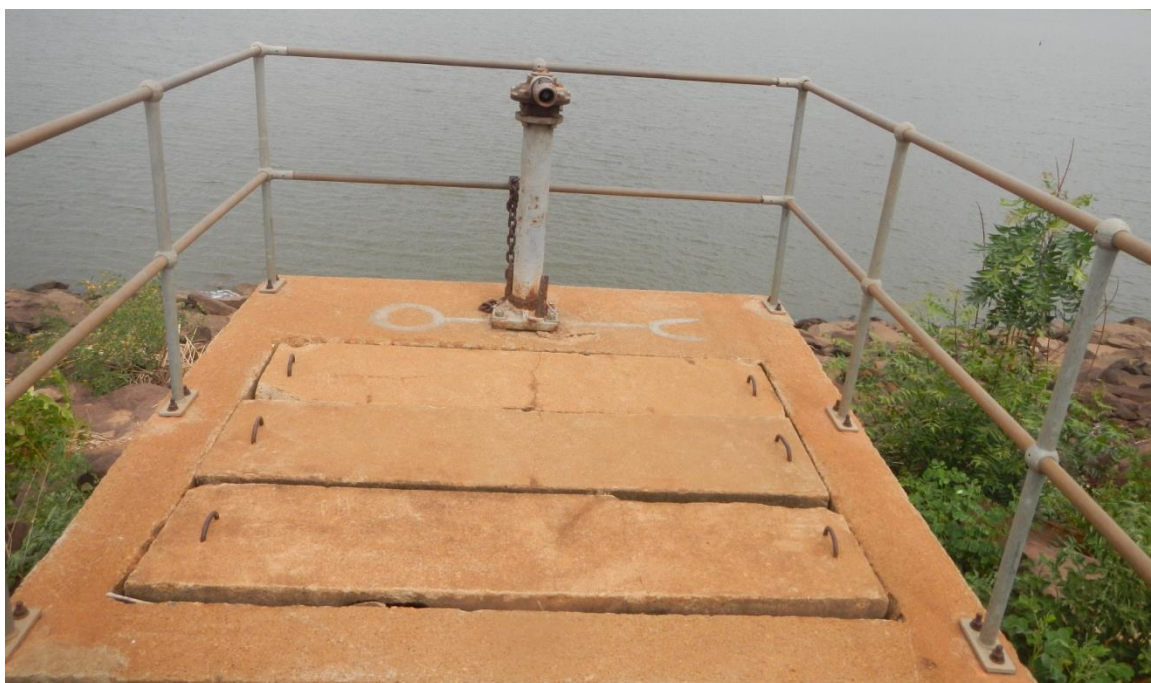
**Appendix A7: Left Bank Canal Off-take Valve at Bontanga Irrigation Scheme**
