**PERFORMANCE EVALUATION OF IRRIGATION SCHEMES IN THE  
TRANSITION AGRO-ECOLOGICAL ZONE OF GHANA**

**A THESIS SUBMITTED TO THE DEPARTMENT OF AGRICULTURAL**

**IN IRRIGATION AND DRAINAGE ENGINEERING**

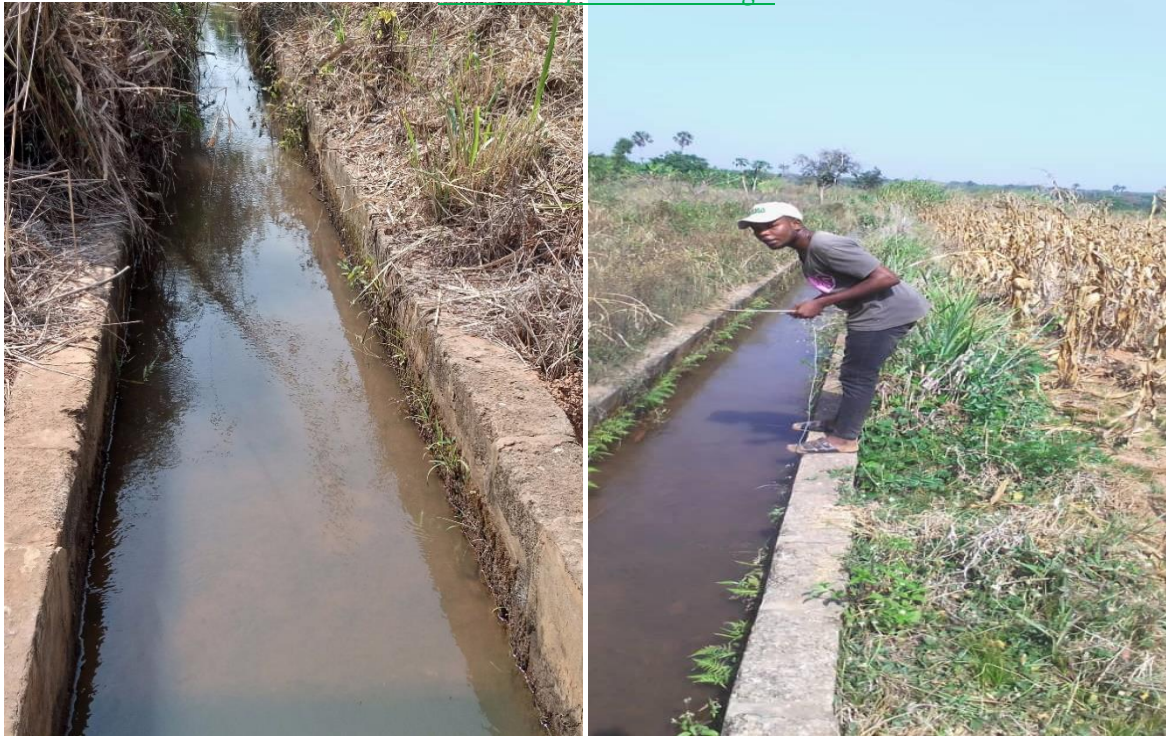
**Plate 3.1: Measurement of Canal Dimensions and Flow-depth at Kaniago Irrigation scheme**

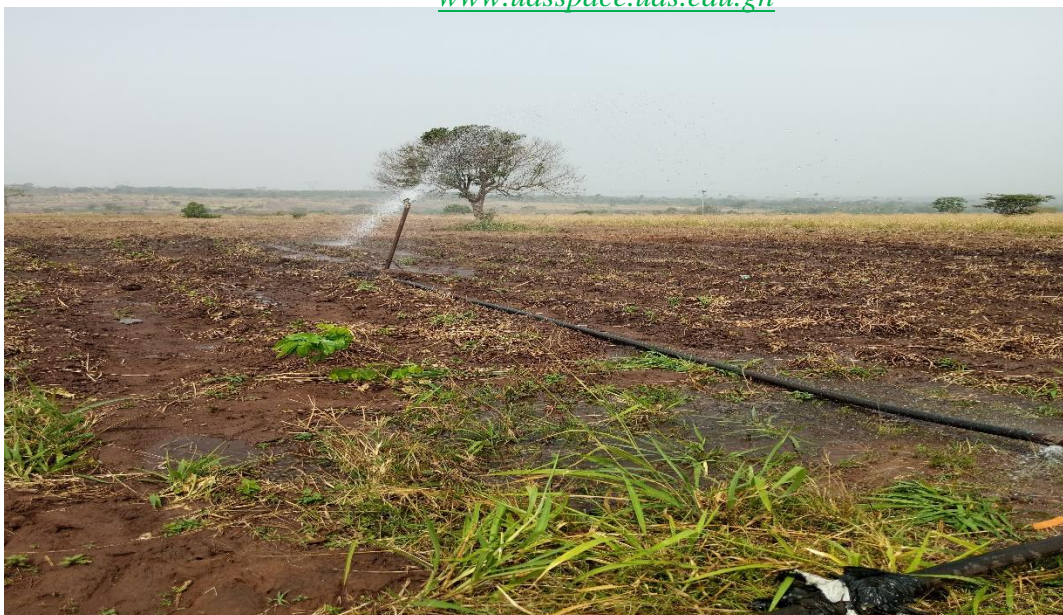
**Figure 3.2: Water Distribution in the Field by the Rotating-impact Sprinkler**

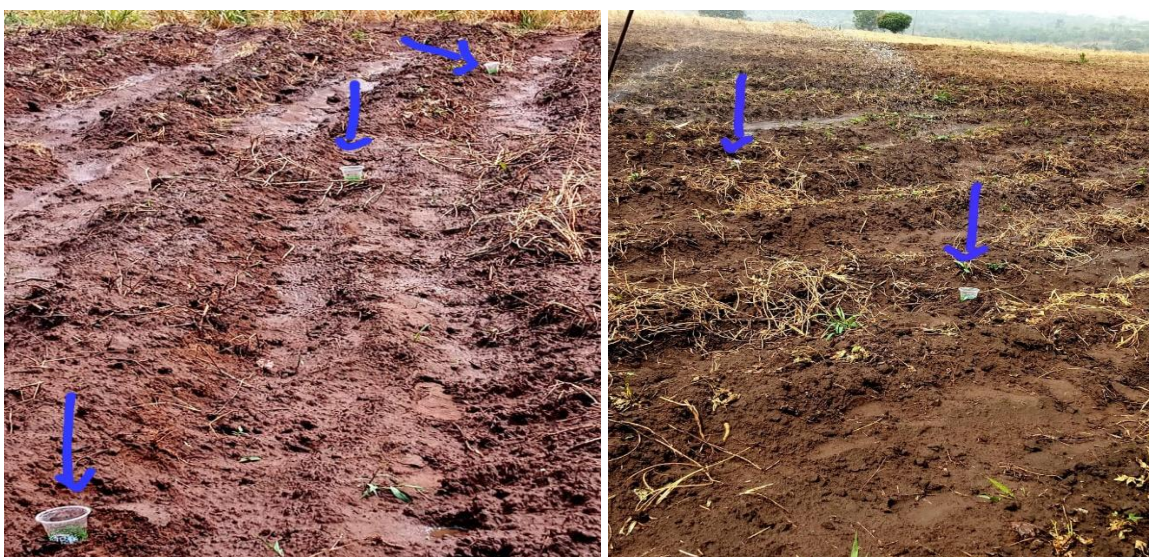
Shown in Plate 3.2 was the arrangement of catch cans in the experimental area.

**Plate 3.2: Blue Arrows Depicting Catch Cans Arrangement in the Field**

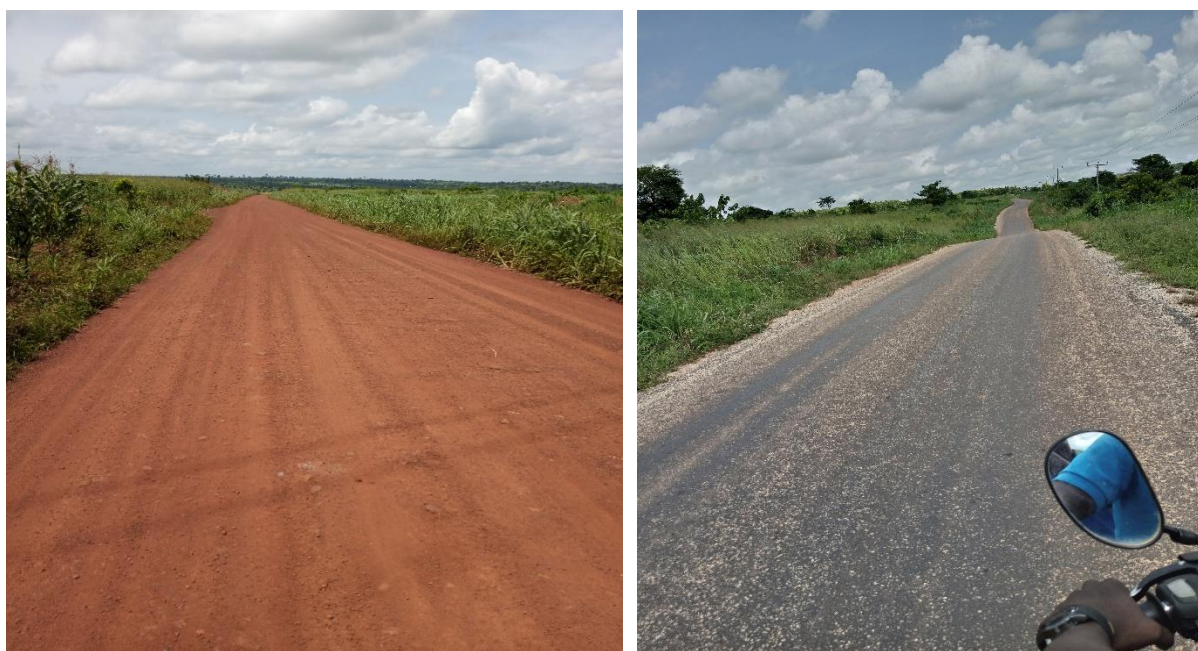
ensuring easy transport of farm input and produce and improvement of inspection and maintenance works on the scheme. The roads within the Akumadan scheme were rehabilitated in the year 2016 when the President of the Republic of Ghana visited the scheme to commission the Akumadan Greenhouse village project. This gave a facelift to the entire road network in the scheme. According to Ijir (1994), the ideal efficiency of roads passability of an irrigation scheme is 100 %. Shown in Plate 4.1 is the current state of the road network within and around the Akumadan irrigation scheme.

**Plate 4.1: The Nature of Road Network at Akumadan Scheme**

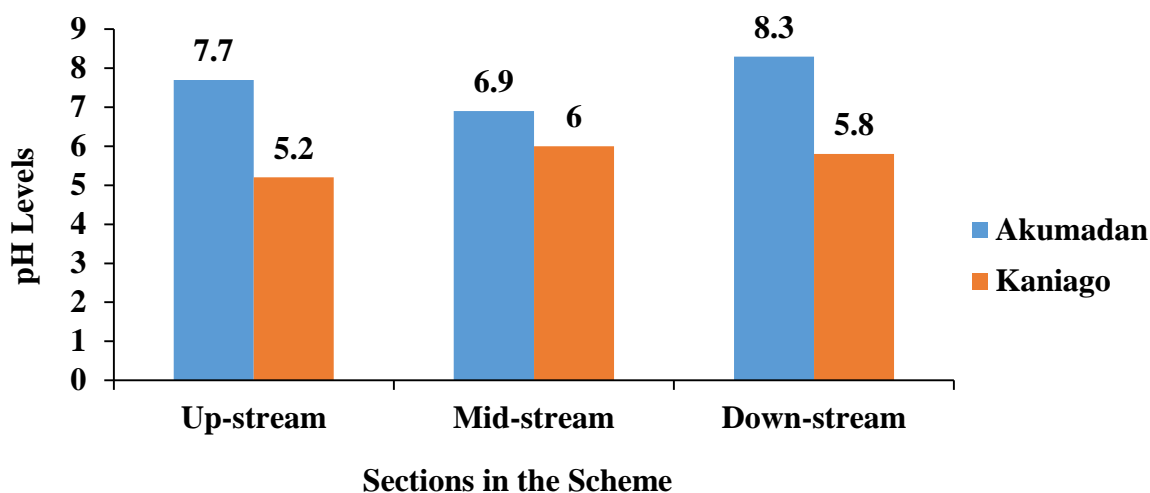
**Figure 4.4: Soil pH Levels of Irrigable Areas**

The Figure 4.4, shows varying soil pH levels at various sections in the irrigable area of the schemes. The Kaniago scheme recorded average soil pH of 5.7 depicting moderately acidic soils. Soils from Akumadan scheme recorded average pH value of 7.6 indicating slightly alkaline soils in the irrigable area of the scheme. The T-test analysis performed on pH of soils

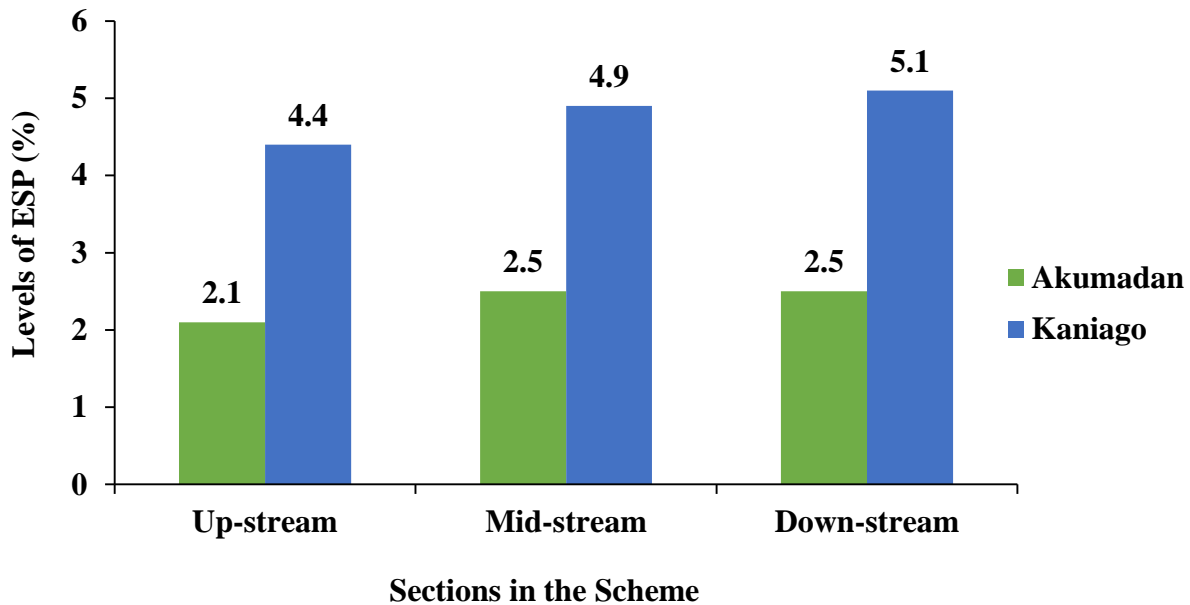
**Figure 4.6 : Level of Sodicty in the Soils of the Irrigation Schemes**

The average ESP values recorded at Akumadan (2.4 %) and Kaniago (4.8 %) showed differences in proportions of sodium in soils of the irrigable areas of the schemes. The P-value of 0.00641 ( $< 0.05$ ) from T-test analysis shows a significant difference in sodium levels across the streams of both schemes. It was realised that the ESP of soils within the irrigable areas of the schemes were at acceptable levels that do not interfere with vegetable crop growth and development. As indicated by USDA Natural Resources Conservation Service (2003), soils with ESP less than 15 % are normal soils whereas soils with ESP greater than 15 % are sodic soils. Per the results obtained, it can be ascertained that ESP and EC concentrations in all the studied schemes were low; hence the soils were free of salt-related problems (salinity and sodicty).

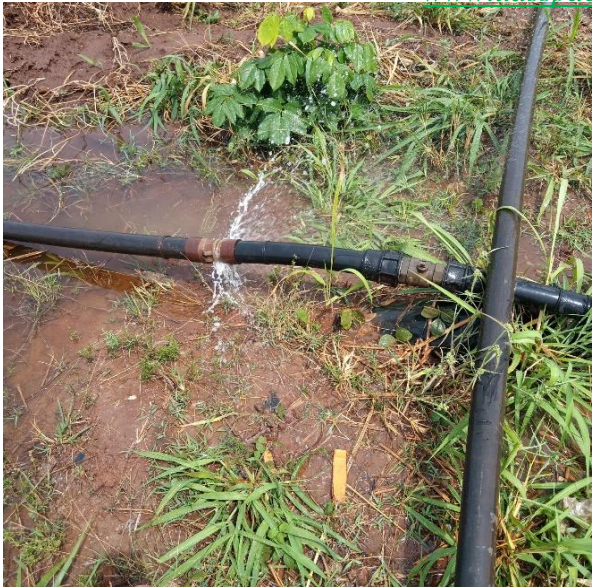
Regarding the condition of infrastructure, the Akumadan scheme was confronted with challenges of many faulty sprinkler heads, inadequate laterals with un-fit coupling and hydrants having broken valves. These challenges affected conveyance and uniform distribution of water on the scheme. At Kaniago, the infrastructure challenges were that of faulty hydrants and poorly designed canal slope that resulted in low gravity flow in the main canal hence affecting water conveyance to the downstream of the scheme. Shown in Plates 4.2 and 4.3 are photographs of poorly functioning infrastructure in the Akumadan and Kaniago schemes.

**a) Leaking Pipe lateral with Unfit Coupling**

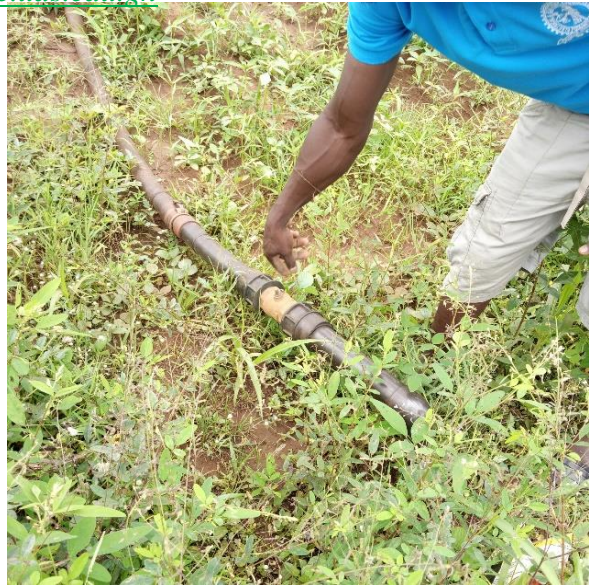
**b) Hydrant with Broken Valve**

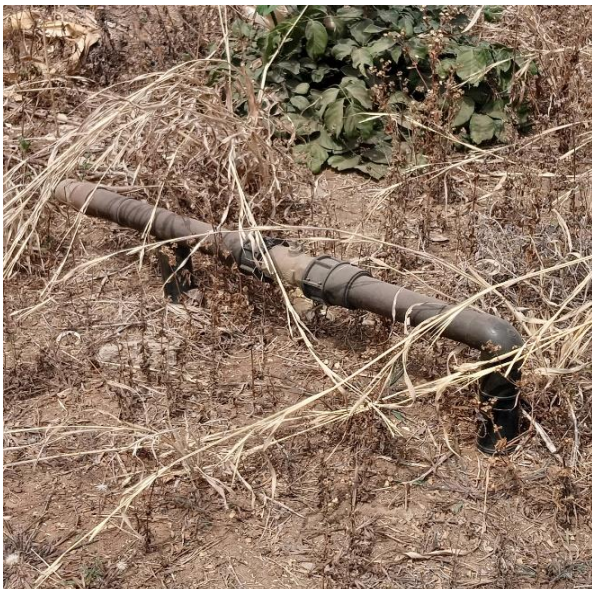
**c) Faulty Hydrant Abandoned in the Scheme**

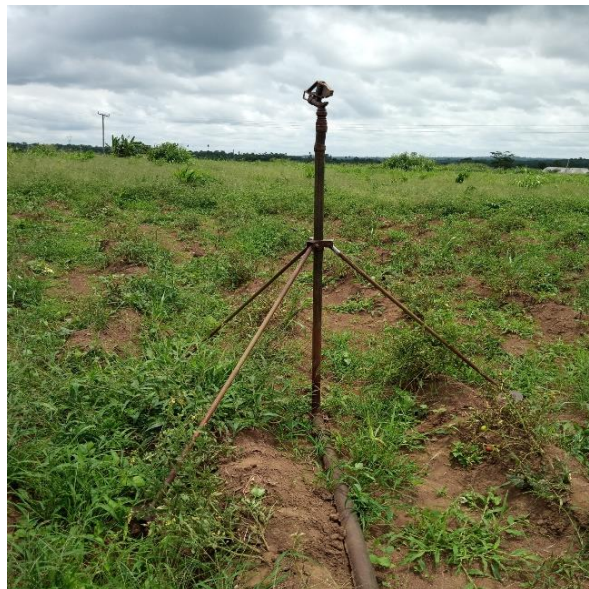
**d) Faulty and Abandoned Sprinkler**

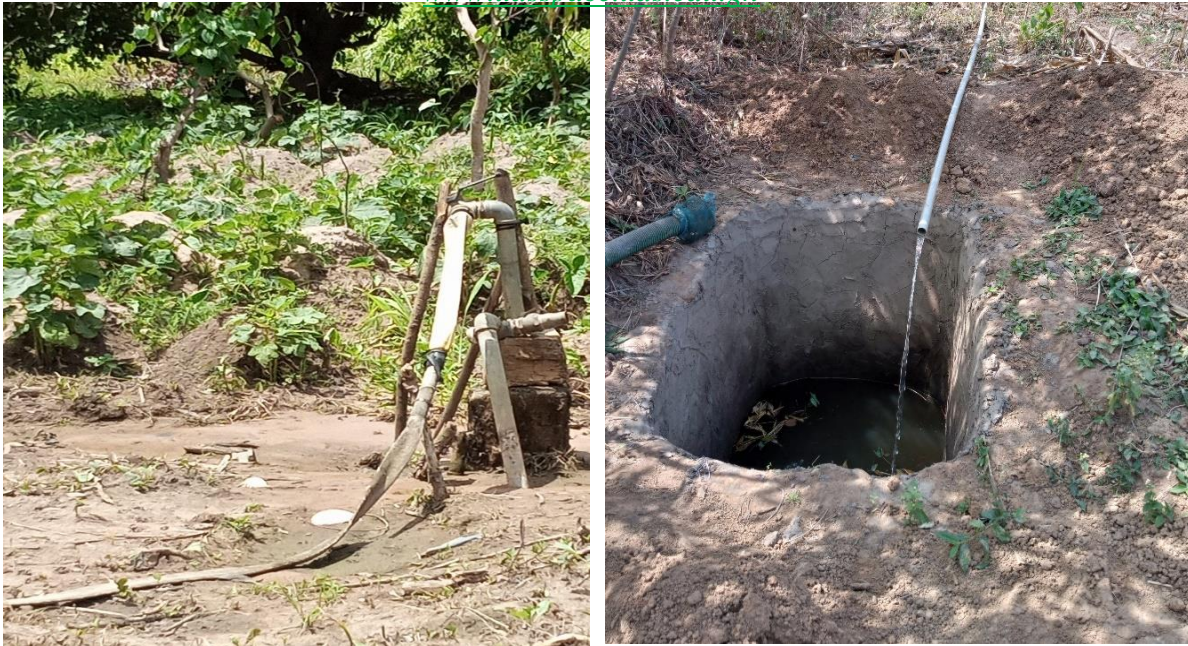
a) A Faulty Hydrant

b) Evidence of Low Gravity Flow in the Downstream of the Scheme

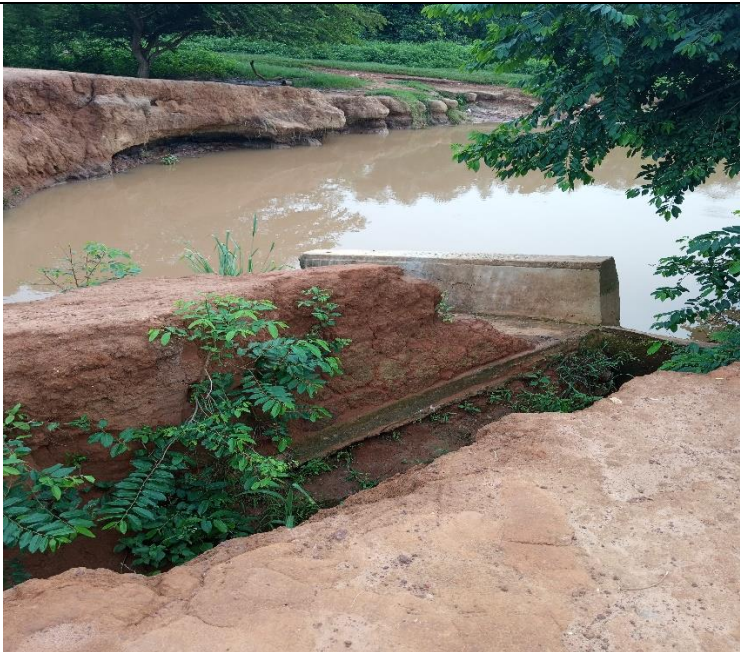
<p>a) Broken Dam Wall in the Scheme</p>	<p>The major problem identified on the Tanoso scheme was that of a broken dam wall. This made it difficult for the reservoir to hold water for irrigation. The problem initially began with cracks on the dam wall and later aggravated to the complete collapse of the wall.</p>

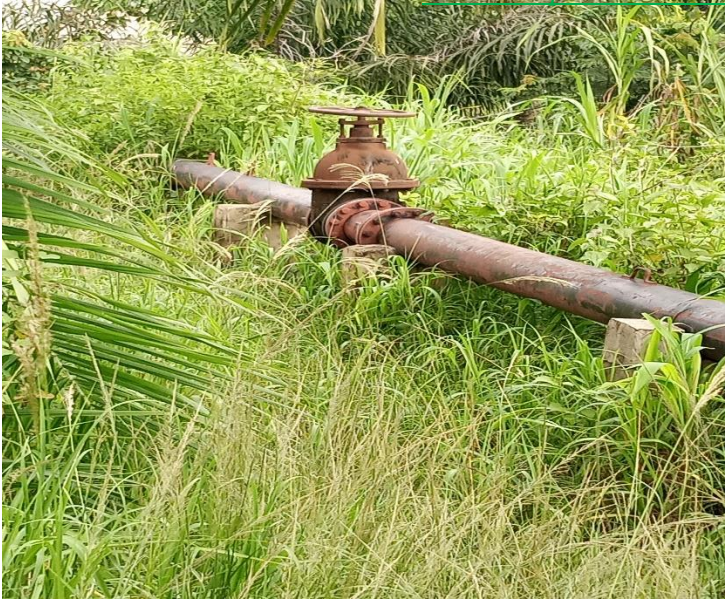
**b) Section of the Main Pipeline**

The main pipeline had been left surrounded by bushes due to closure of operations on the scheme.

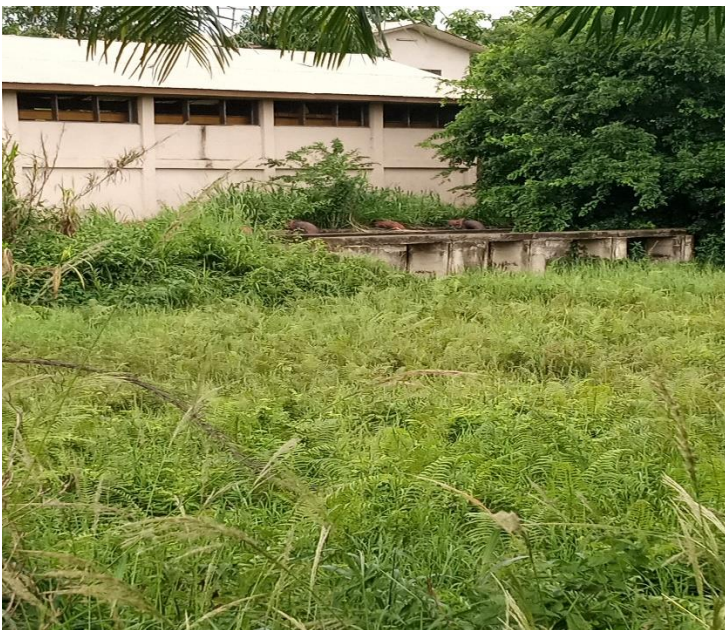
**c) Suction End of the Pumphouse**

The Suction end of the pumphouse was left unkept and covered by bushes. The caretaker of the scheme revealed that this condition had existed since the year 2019.

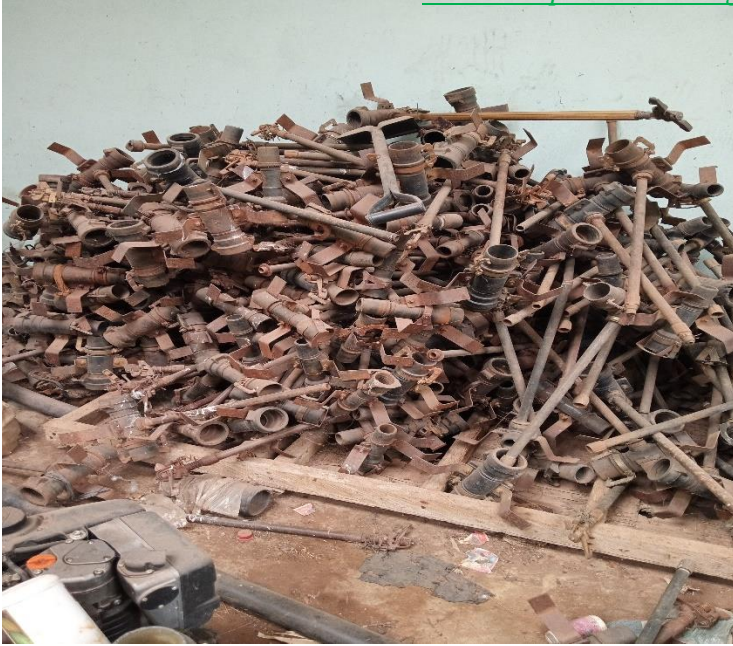
These sprinklers were faulty, hence abandoned at the warehouse of the scheme.

**d) Faulty Sprinklers Deposited at the Scheme's Warehouse**

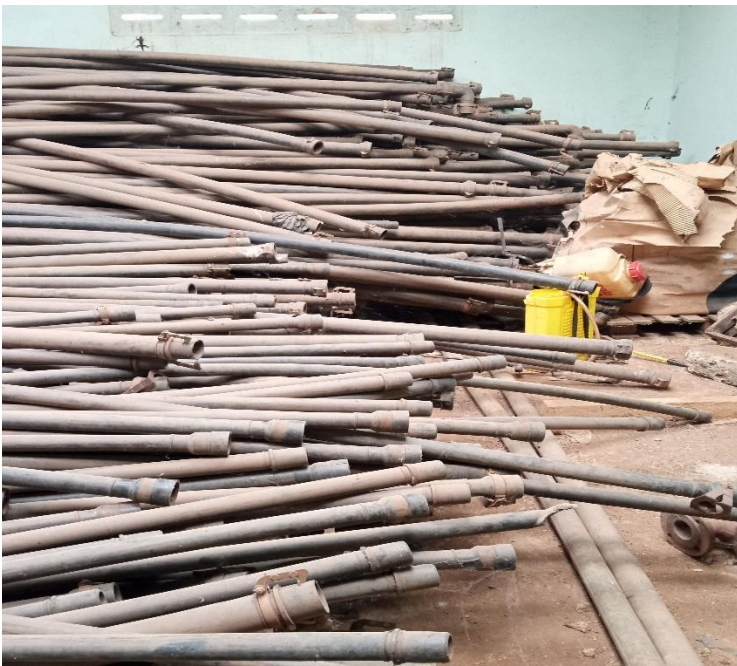
This photograph shows a bunch of dismantled pipe laterals deposited at the warehouse of the scheme.

**e) Pipe Laterals**

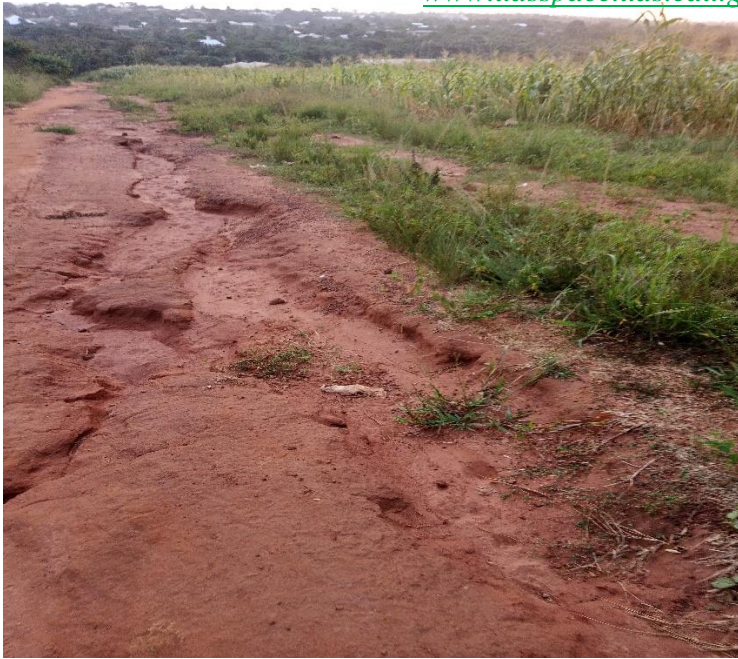
0.21 km of the total road length of 2.4 km in the scheme had been eroded by running water as a result of heavy rains.

**f) Eroded Road Network**

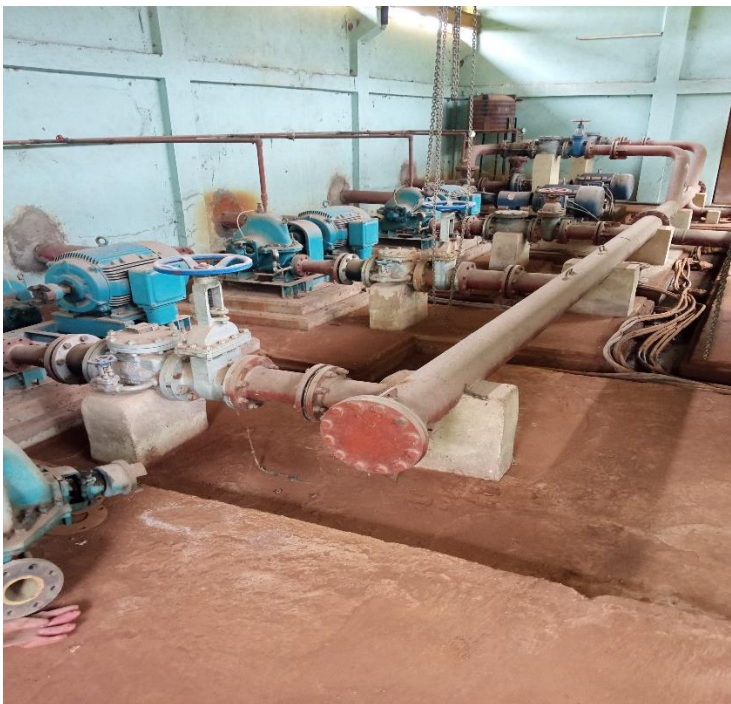
It was observed that the floor of the control room was covered by remnants of sand due to the constant flooding of the place. This could lead to greater damage in future if flood control measures are not put in place on the scheme.

**g) Pump Control Room**

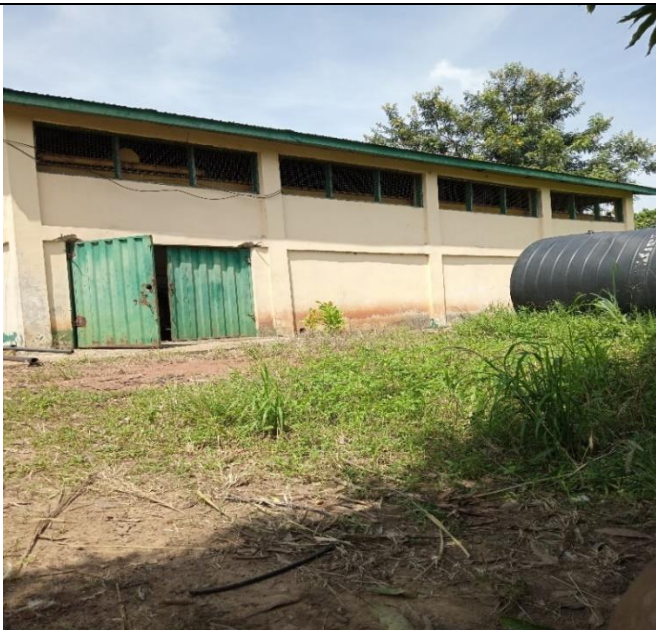
<p>a) Abandoned Pumphouse</p>	<p>The pumphouse being an important component of the scheme had broken down because the scheme was over-burdened with huge electricity costs. This resulted in the disconnection of power supply from the national electricity grid thereby rendering the pumphouse defunct.</p>

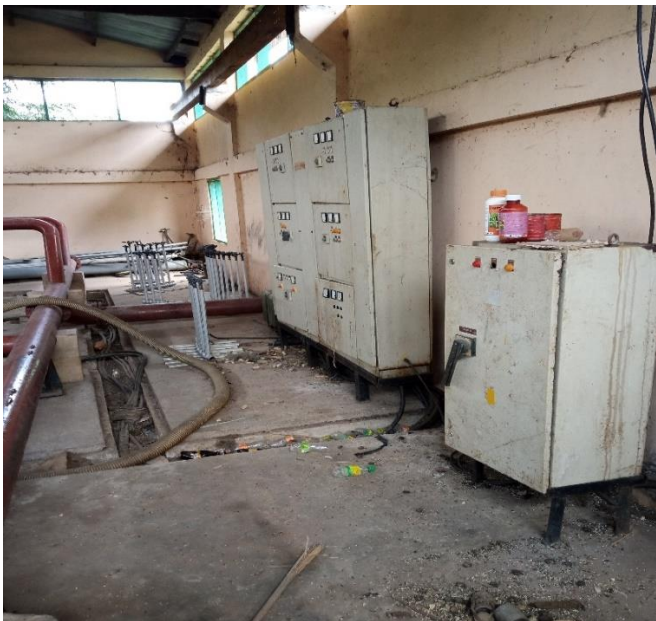
<p>b) Faulty Power Panel</p>	<p>An important component of the pumphouse is the power panel which regulates the electric voltage as required by the pumps for their operation. It serves as the engine-starter of the pump. According to the manager of the scheme, the panels had being left dilapidated following closure of operations for the past seven (7) years.</p>
